Symptom - Engine - Coolant Reservoir Cap Leaking: Further rework required (SY 11/18)

Model Line: **718 Boxster (982)**
718 Cayman (982)

Model Year: **As of 2017 up to 2018**

Subject: **Coolant reservoir cap**

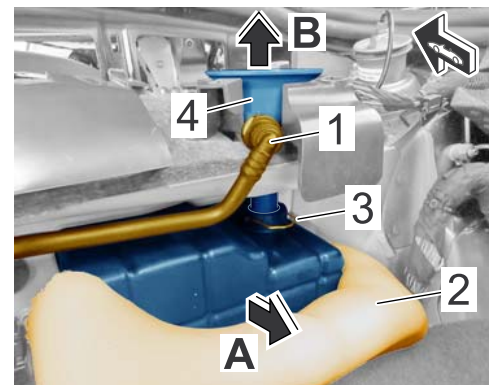
Coolant reservoir filler neck

Symptom: **Coolant is leaking out at the coolant reservoir cap.**

Cause: The coolant reservoir cap may have been overtightened.
 The locking lug for the limit stop of the coolant reservoir cap has broken off.

For this fault type, the coolant reservoir cap **and** the coolant reservoir filler neck **must** be replaced.

- 6 Remove coolant reservoir filler neck (⇒ *Coolant reservoir filler neck -4-*).
 - 6.1 Loosen spring clamp (⇒ *Coolant reservoir filler neck -3-*).
 - 6.2 Pull coolant reservoir filler neck (⇒ *Coolant reservoir filler neck -4-*) up and off (⇒ *Coolant reservoir filler neck -arrow B-*).
