Technical Service Bulletin

01 MIL on, DTC P243600 and/or P243700 stored in ECM

01 18 56 2049142/2 March 2, 2018. Supersedes Technical Service Bulletin Group 01 number 17-40 dated October 23, 2017 for reasons listed below.

| Model(s) | Year | VIN Range | Vehicle-Specific Equipment |
|---|---|---|---|
| R8, R8 Spyder | 2017 | 000001 - 905000 | Not Applicable |

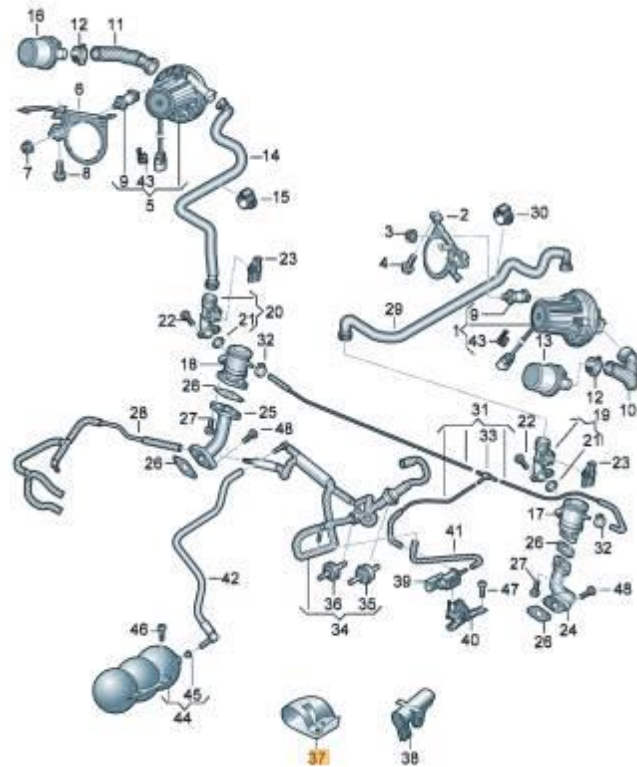
Figure 1. Replace the sender.

- **DTC P243600** (Secondary Air Injection System Air Flow/Pressure Bank 2 Sensor Circuit Range/Performance)

- **DTC P243700** (Secondary Air Injection System Air Flow/Pressure Bank 2 Sensor Circuit Low)

According to the Guided Fault Finding, the differential pressure sensor Bank 2 (G610) has to be replaced.

1. Replace the Differential pressure sensor Bank 2 (G610) according to the Repair Manual, *Engine >> 24 Multiport fuel injection >> air filter housing, removing and installing >> 26 Exhaust System>Secondary Air System >> Combination valve, removing and installing >> Secondary air injection sensor G609/G610, removing and installing.*
2. Then add the insulation (Figure 1, number 37) on the pressure sensor Bank 2.
