Technical Service Bulletin

91 Night vision system inoperative, DTC B201000 (no basic settings)

91 18 85 2045020/2 March 8, 2018. Supersedes Technical Service Bulletin Group 90 number 16-70 dated August 31, 2016 for reasons listed below.

Model(s)	Year	VIN Range	Vehicle-Specific Equipment
Q7	2017 - 2018	All	With night vision system
A6, A7	2015 - 2018	All	With night vision system

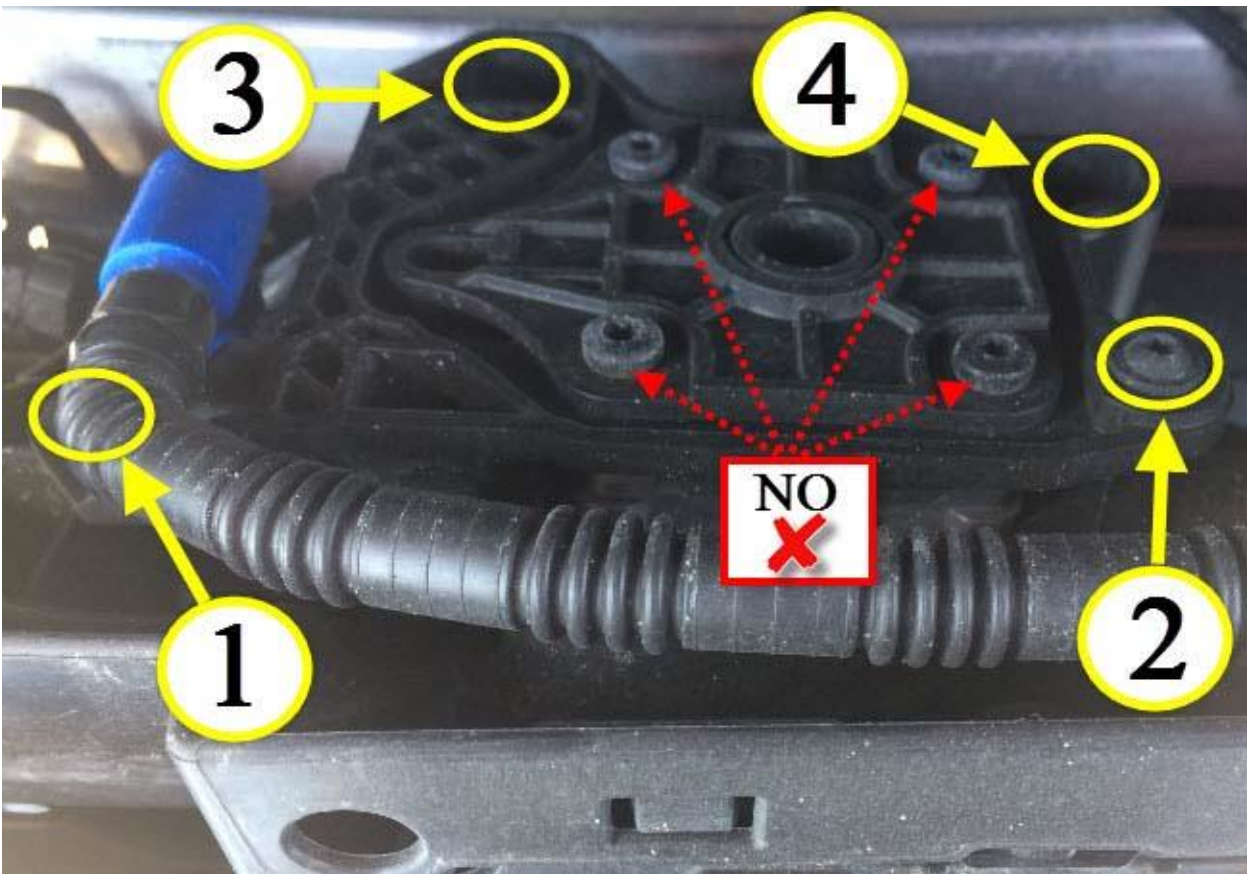
- Loosen the night vision camera mounting bracket by loosening the four mounting screws that hold the mounting bracket to the radiator grill. Mounting screws are shown in the image below (Figure 1) by numbered arrows 1, 2, 3, and 4. Do not remove or loosen the four screws that hold the camera onto the camera mounting bracket, these are shown in the image with red dotted arrows.

Figure 1. Night Vision Camera Mounting Bracket Screw Retainer Locations 1, 2, 3, and 4. Loosen screws 1, 2, 3, and 4. Do not remove or loosen the four screws holding the camera to the bracket.

- Place a single spacer, part number N01152322, between each of the two upper mounting points that secure the night vision camera bracket to the radiator grill. These screws are shown in the above image as points 1 and 2 (Figure 1). The image below (Figure 2) references these points on the radiator grill as 1 and 2. The next image (Figure 3) shows placement of the spacer on the camera as points 1 and 2, the camera has been removed for clarity.
