**18-2024**25 January
2018**TECHNICAL SERVICE BULLETIN**
Lack Of Heat - Blower Motor Frozen - Cold Weather Conditions

This bulletin supersedes 16-0018. Reason for update: Concern Carryover to New Model

Ford 2011-2017 Fiesta

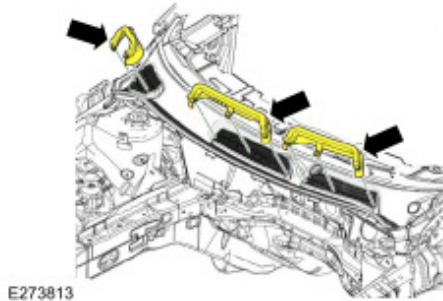
Figure 1

Issue: Some 2011-2017 Fiesta vehicles may exhibit a lack of heat resulting from a frozen blower motor. This may be caused by snow entering through the cowl panel grille and prior screen assemblies. Snow may melt in the heating, ventilation and air conditioning (HVAC) case allowing water to enter the blower motor and freeze during a below freezing overnight soak. The blower motor fuse at location F4 in the power distribution box may also be open and the cabin air filter may be water saturated.

- (1). Yes – refer to Workshop Manual (WSM), Section 412-00 for normal diagnostics.
 - (2). No - proceed to Step 2.
- 2.** Replace the cabin air filter. Refer to WSM, Section 412-00.
- 3.** Open the hood and inspect for the presence of foam deflectors on the air inlet openings of the cowl opening grille. (Figure 1). Are deflectors present?
- (1). Yes – remove and discard the foam deflectors. Proceed to Step 4.
 - (2). No - proceed to Step 4.
