NA_MACK_Vehicle_Range

Mack Chassis - Diagnostic Trouble Code (DTC) P226C Intermittently Lighting The Malfunction Indicator Lamp (MIL) - **US14+OBD13, US14+OBD15 And US14+OBD16 Emissions (Non-Common Rail Fuel System), Commonly Model Years 2015 to 2017**

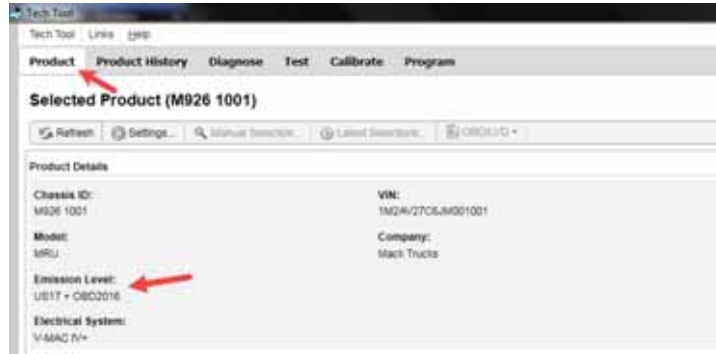
Verify the chassis emissions level

- Details can be found in the Product Details box on the Product tab in PTT as seen below:

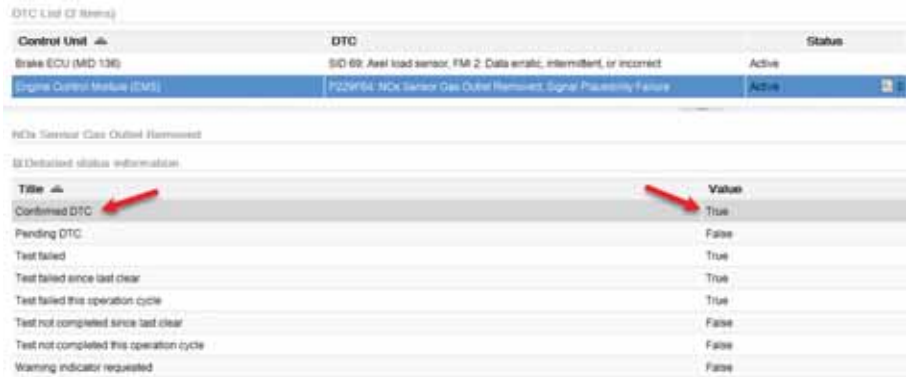
Review the Detailed Status Information for the relevant code on the DTC Readout.

If software is found to be current, diagnosis should only proceed if the Confirmed DTC status for P226C is True as shown above. If the status is False, other symptoms or fault codes should be diagnosed and the codes cleared when complete.
