SERVICE BULLETIN

APPLICABILITY: 2017-18MY Impreza
 2018MY Crosstrek
 2018MY Legacy and Outback

NUMBER: 15-211-17R
DATE: 06/13/17
REVISED: 12/19/17

SUBJECT: Reprogramming File Availability for Additional Optimization of Harman Gen 3 Audio and Navigation Head Units

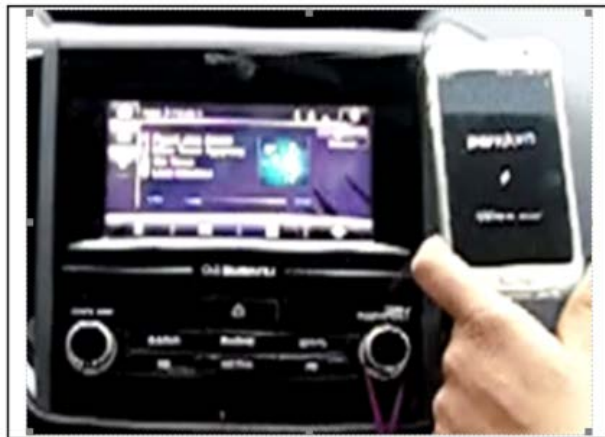
- 1- No streaming audio. When using the Pandora® app, there is no audio output.

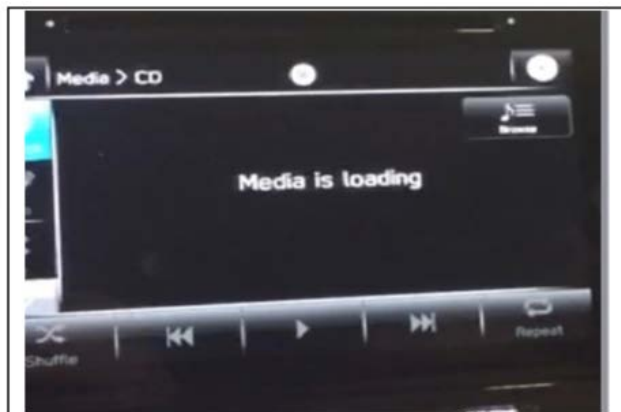
- 2- “Media is loading” is displayed on the screen but, the media never completes loading.

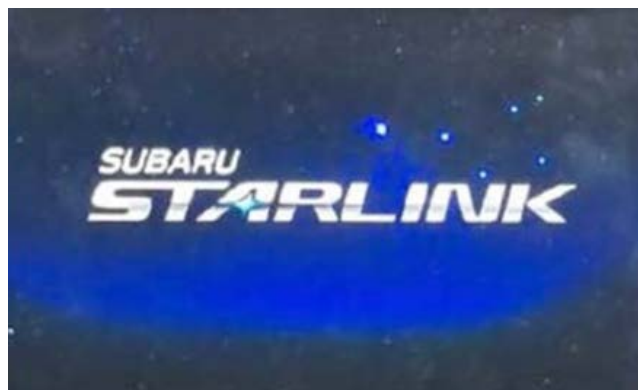
- 3- The screen freezes when the STARLINK screen is displayed.

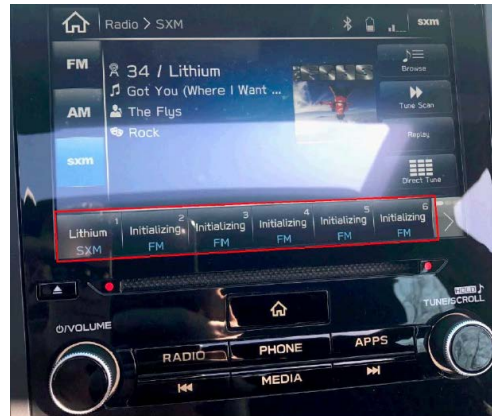
- 1- Radio station presets disappear (touch screen buttons return to “Initializing”).

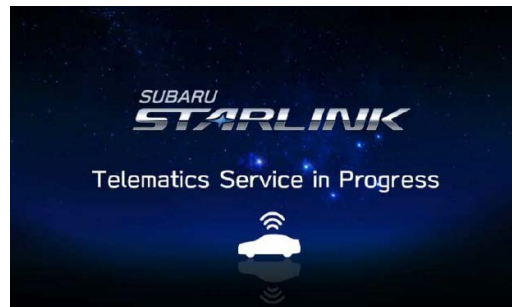
- 2- STARLINK “Telematics Service in Progress” screen freezes.

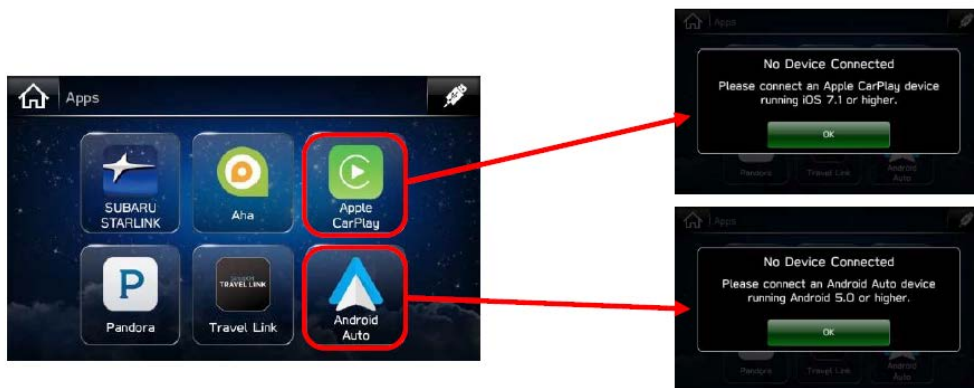
- 3- Apple Car Play / Android Auto function does not operate (“No Device Connected”).

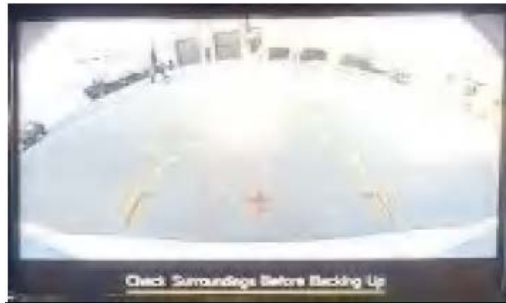
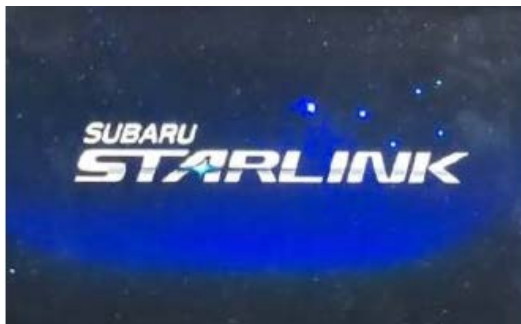
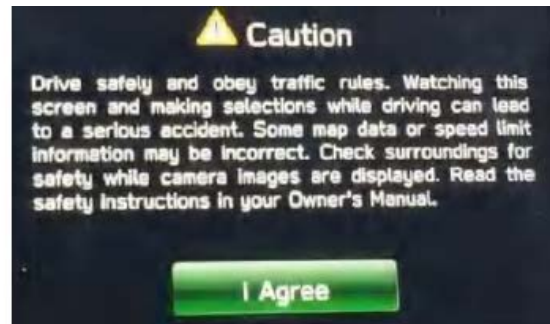
For reference, the previously released WTN-74R symptoms are also provided below. The main purpose of WTN-74R was to address display screen freeze-up during Back-Up Camera display (when the shifter is in “R”). In addition, the screen may also freeze when either the Subaru STARLINK or Disclaimer Caution / I Agree screen is displayed.

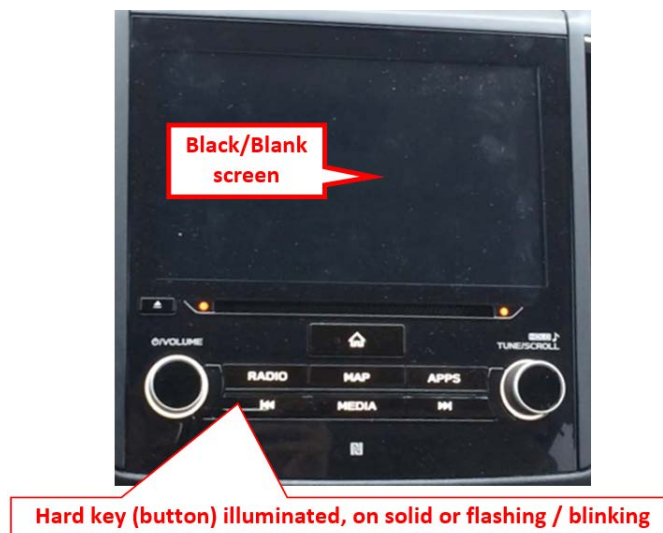
- 1) After switching the vehicle (ACC or IGN) on, the display screen goes black with no audio output and the hard key buttons are illuminated (on solid, or flashing / blinking).

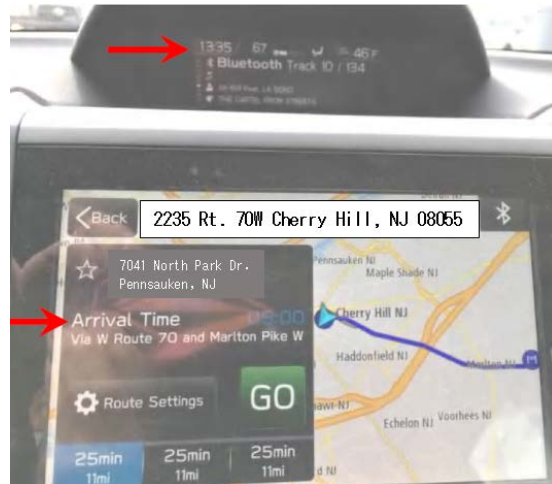
- 2) Time of day displayed in the MFD (Multi-Function Display) is incorrect and the arrival time displayed in Navigation units is also incorrect.

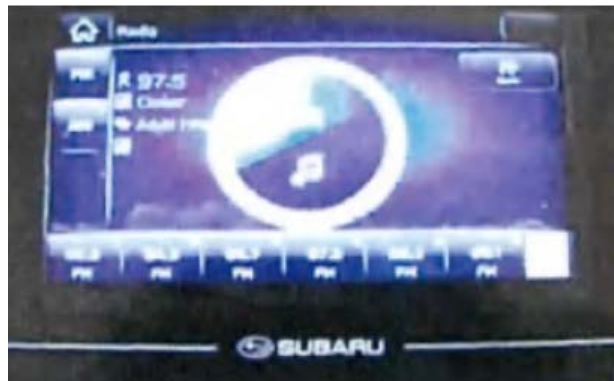
- 3) The time in the MFD automatically reverts to a “default” setting, even after setting the time using “Manual” mode.
- 4) Audio volume goes to maximum automatically after one click of the volume up button on the steering wheel. In some cases, this condition may also occur without input from the operator. Maximum volume is also displayed on the screen.
