NA_VOLVO_Vehicle_Range VN~~X~~, VN~~L~~, VN~~M~~, VHD, VAH

Title (customer effect) Volvo Chassis - Diagnostic Trouble Code (DTC) P226C Intermittently Lighting The Malfunction Indicator Lamp (MIL) - **US14+OBD13, US14+OBD15 And US14+OBD16 Emissions (Non-Common Rail Fuel System), Commonly Model Years 2015 to 2017**

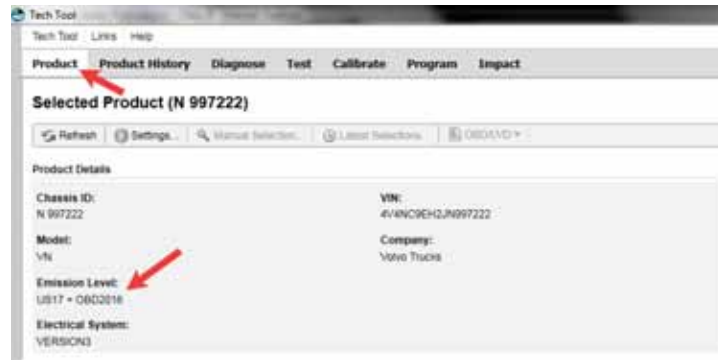
- Details can be found in the Product Details box on the Product tab in PTT as seen below:

Verify the chassis emissions level

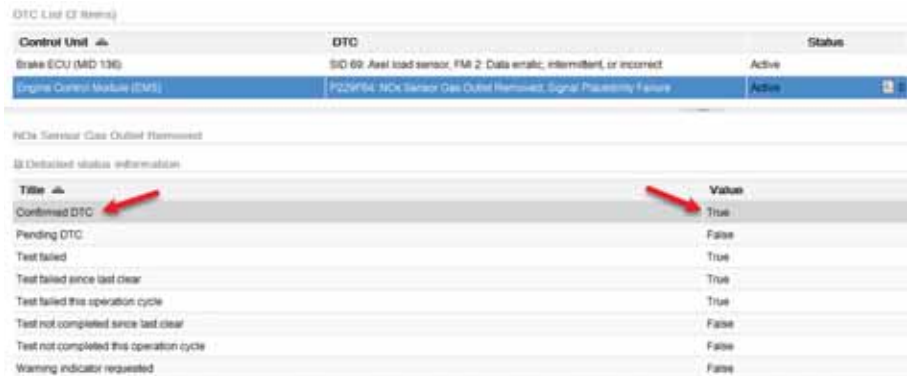
Review the Detailed Status Information for the relevant code on the DTC Readout.

If software is found to be current, diagnosis should only proceed if the Confirmed DTC status for P226C is True as shown above. If the status is False, other symptoms or fault codes should be diagnosed and the codes cleared when complete.
