NA_MACK_Vehicle_Range

NA_VOLVO_Vehicle_Range

Title (customer effect) Selective Catalytic Reduction (SCR) Efficiency And NOx Sensor Codes P225C, P225E, P221A, P2201, P103C, P20EE, And P207F : **NOx Sensor Diagnostic Information TO BE USED BEFORE SENSOR REPLACEMENT - OBD13 And Newer Emissions (Commonly Model Year 2014 And Newer)**

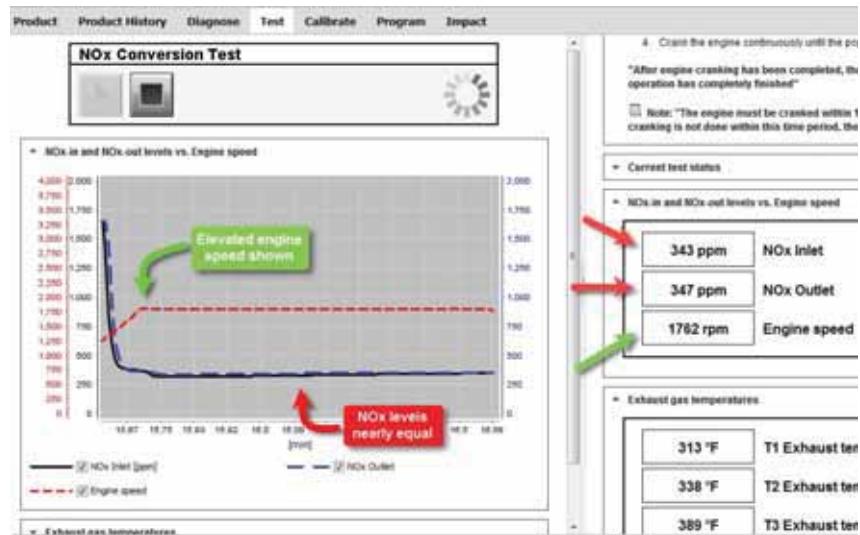
- Inlet and Outlet NOx values should be within 40 parts per million (ppm) of one another just before the engine shuts down. Shown below is an example of how a graph

with two properly functioning sensors will look:

3. If no issues are found with the sensor readings from the NOx Conversion review, the sensors are not the source of the conditions causing the codes to log. Further diagnostic steps of other components will need to be performed to determine the cause of the faults.

5. If diagnostic steps do not locate a root cause for the code(s), open an eService case with Dealer Technical Support
 - The screenshot(s) taken of the NOx conversion screen prior to engine shutdown (as shown in the screenshot above) should be attached to the case.
