**NUMBER:** 08-034-16 REV. A

RL4 Radio Enhancements

**\*\*2015 - 2016 (BU) Jeep Renegade\*\***

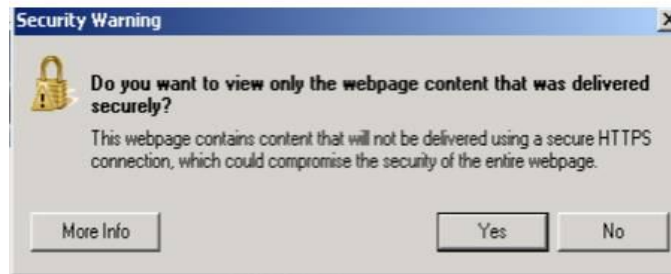
***Fig. 1 Pop-up Security Message***

- b. No >>> Proceed to [Step #2](#).
2. Go to DealerCONNECT> Service> UCONNECT Information & Utilities> Uconnect Dealer software downloads to download the files.
3. If a security message appears “Do you want to view only the webpage content that was delivered securely?” see ([Fig. 1](#)). Press **No** to continue.
