# Service Bulletin

**Subject:** Magnaride™ Magnetically Controlled Suspension Electrical Connector Not Seated, Service Suspension System Message, DTCs C0575, C0580, C0585 or C0590

**Models:** 2006-2011 Buick Lucerne  
2002-2011 Cadillac STS  
2004-2009 Cadillac SRX, XLR  
2006-2009 Cadillac XLR-V  
2006-2011 Cadillac DTS  
2006-2013 Cadillac Escalade EXT  
2006-2014 Cadillac Escalade, Escalade ESV  
2009-2014 Cadillac CTS-V (Coupe, Sedan, Wagon)  
2003-2013 Chevrolet Corvette  
2006-2013 Chevrolet Avalanche  
2006-2014 Chevrolet Suburban, Tahoe  
2006-2014 GMC Yukon, Yukon XL  
Equipped with RPO F55, Z55 or Z95

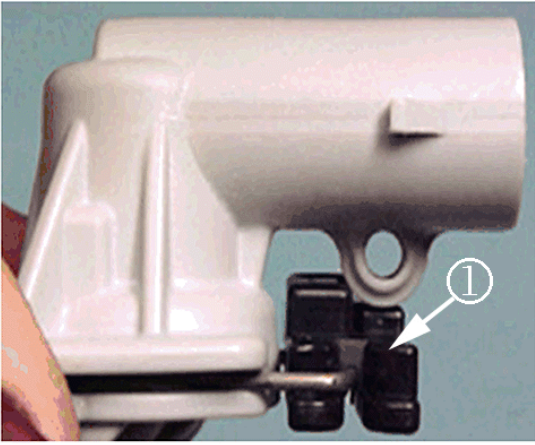
**Connector with Position Assurance (CPA) Tab (CTS Only)**

CTS Models built after February 22, 2011 have a CPA tab (1) as shown above as part of the connector. Vehicles built with this design should be less susceptible to being unseated. The CTS is the only vehicle to adopt this design change. All other products continue with the original style connector.
