Service Bulletin

Bulletin No.: 06-03-09-004K

Subject: Squeak Noise from Rear of Vehicle (Lubricate Rear Leaf Springs)

Models: 1999-2007 Chevrolet Silverado (Classic)
2007-2018 Chevrolet Silverado
2014-2018 Chevrolet Express
1999-2007 GMC Sierra (Classic)
2007-2018 GMC Sierra
2014-2018 GMC Savana
2007-2010 HUMMER H3, H3T

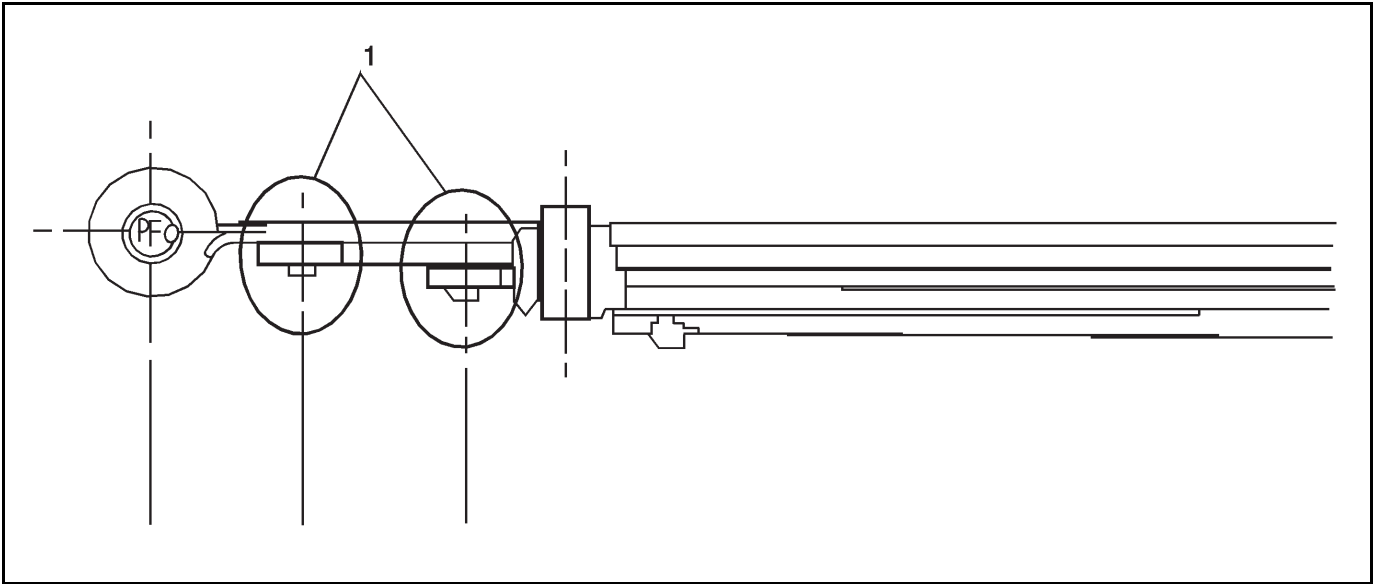
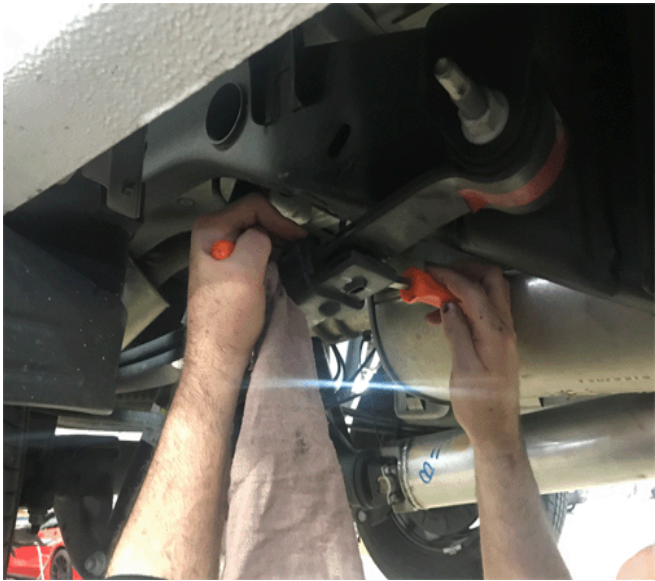
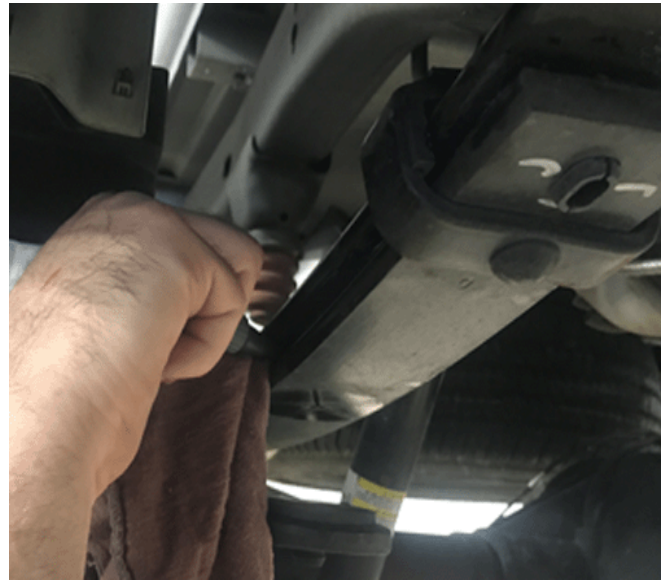
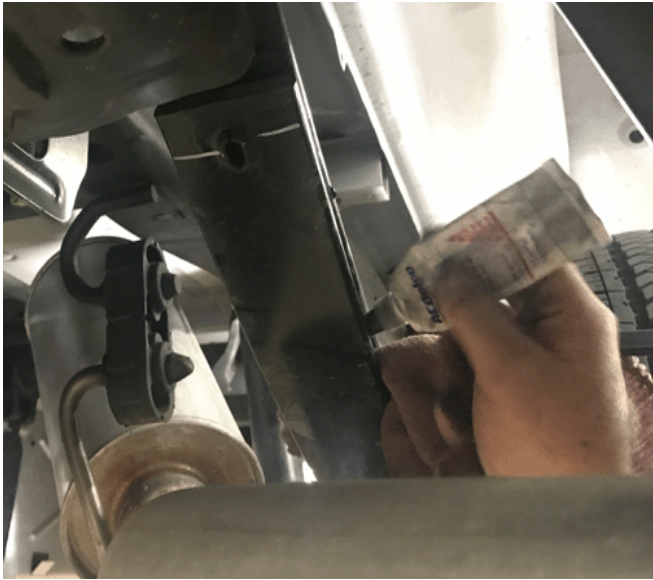
Some customers may comment about a squeak noise coming from the rear of the vehicle. During normal operation, certain vehicles may exhibit a squeaking noise that may be traced to the rear leaf springs. While this noise is an operating characteristic of leaf springs, the frequency and severity of this noise will be affected by the roads that the vehicle is driven on.

This condition may be due to debris getting between the leaf springs.

5. Apply a liberal amount of grease, P/N 19356408 (in Canada, use P/N 19356409), both underneath and on top of the front and rear tip inserts for the #2 and #3 leaves, as indicated above. A screwdriver can be used to gently pry up the leaf; however, a rag around the screwdriver must be used to prevent damage to the leaf. Use a flat-bladed tool, such as a gasket scraper or a brush to properly distribute the grease at least 6 inches from each end of the leaf.
6. Lower the vehicle to the ground and test drive to verify the repair.
