Service Bulletin

Bulletin No.: 16-NA-239

Subject: Information on Enabling 4G LTE Wi-Fi Hotspot on New Vehicle

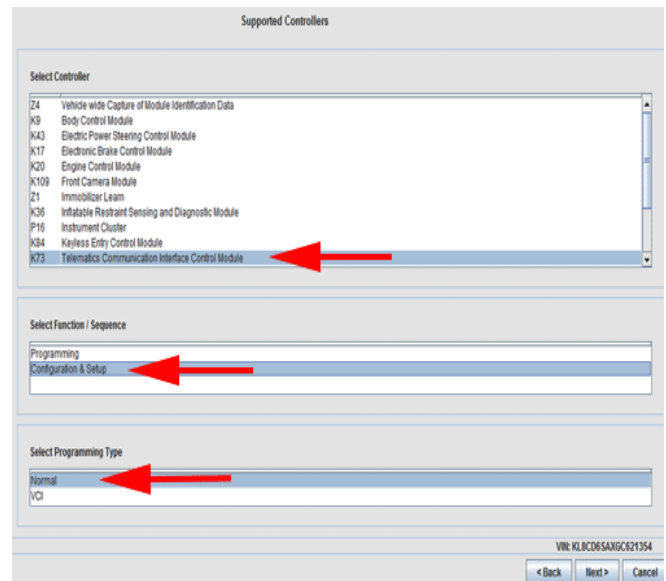
4564321

Note: 2016 Chevrolet Spark shown, other vehicles similar.

4. As shown above, select K73 Telematics Communication Interface Control Module as the Controller Type, Configuration & Setup as the Function/Sequence, and Normal as the Programming Type before selecting Next.
5. Following remaining TIS2web on-screen instructions to enable Wi-Fi.
