SERVICE BULLETIN

Classification:	Reference:	Date:
EL18-014	NTB18-034	April 26, 2018

2017-2018 SENTRA WITH NON-NAVI SYSTEM; AUDIO PRESET BUTTONS STICK DOWN OR SLOW MOVING

APPLIED VEHICLES: 2017-2018 Sentra (B17) with non-NAVI audio system

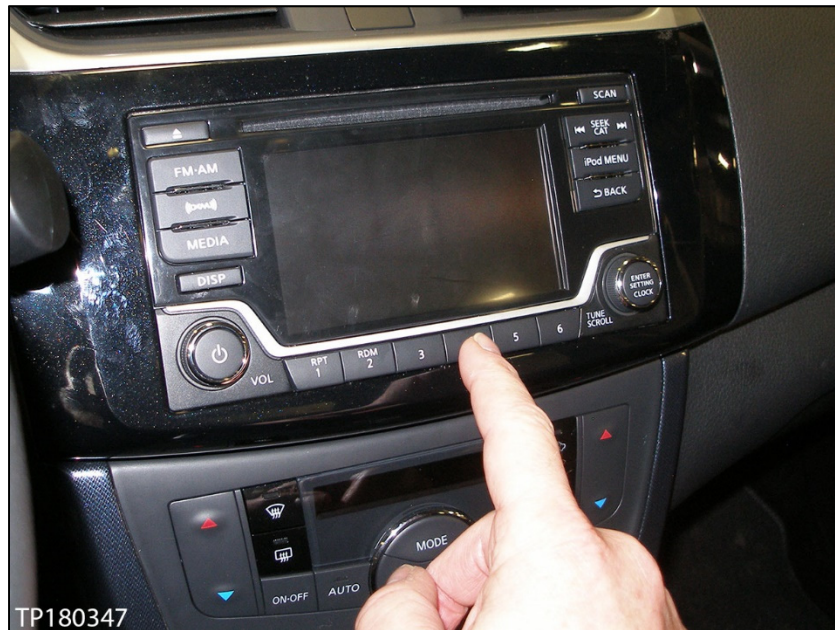
Figure 1

One or more of the audio preset buttons of an applied vehicle sticks down (does not pop up after pushing down) or is slow to move back to its rest position after pushing down.

Reposition, or replace as necessary, the felt tape on the cluster lid C.

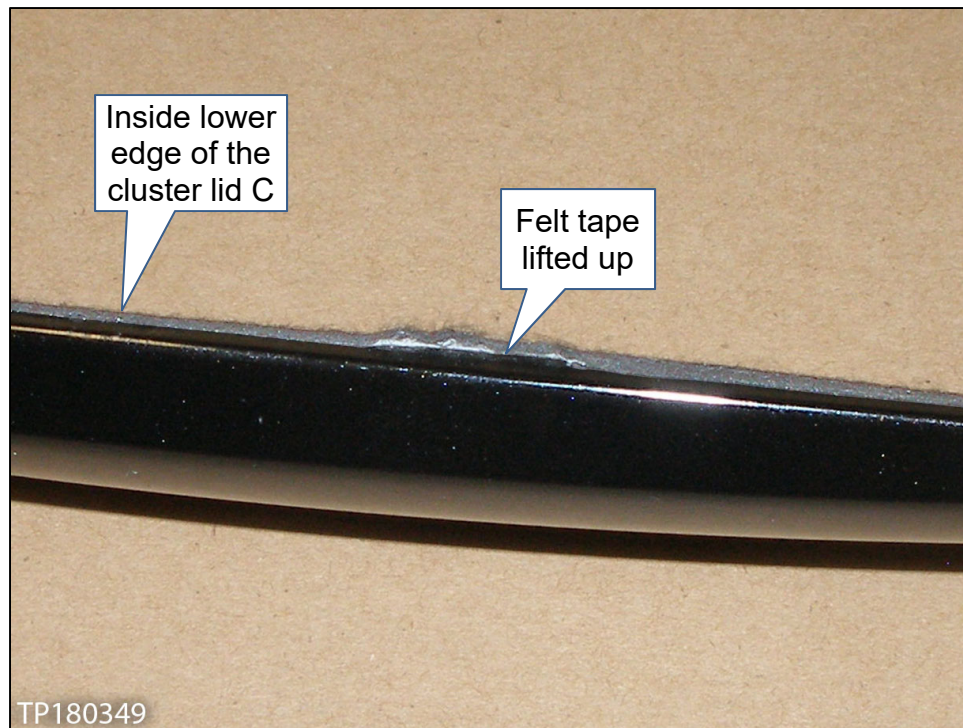
Figure 3

2. Inspect the felt tape along the area where shown in Figure 3.
