SERVICE BULLETIN

APPLICABILITY: 2015MY Legacy, Outback, Impreza, XV Crosstrek and WRX Models with Fujitsu-Ten (F10) 7” Display Audio Systems (without navigation)

NUMBER: 15-183-15R
DATE: 06/17/15
REVISED: 05/02/16

SUBJECT: Procedures for Updating the Head Unit Operating Software

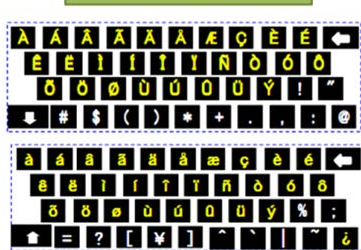
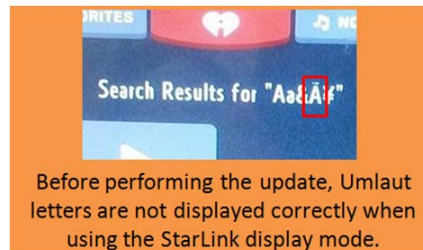
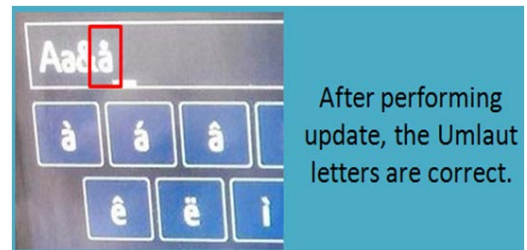
- **Symptom 1:** Audio output is lost after a few minutes when listening to Sirius/XM satellite radio.
Change: Logic update to provide proper Sirius/XM satellite radio operation.
- **Symptom 2:** Bluetooth feature becomes inoperative.
Change: Logic update to provide proper Bluetooth feature operation.
- **Symptom 3:** HD Radio “freezes” after a few minutes of play.
Change: Logic update to provide proper Sirius/XM satellite radio operation.
- **Symptom 4:** Back-Up Camera “help lines” do not appear.
Change: Logic change to have the assist lines appear 8 seconds from engine start.
- **Symptom 5:** Incorrect Umlaut characters are shown on StarLink display.
Change: Logic change to allow proper display of Umlaut letters.

List of incorrect Umlaut letters is shown in yellow.

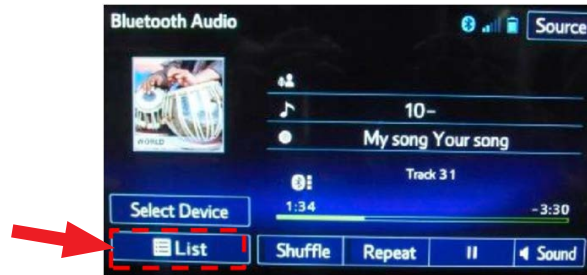
- **Symptom 8:** “Line Diag” screen is intermittently displayed while driving.
Change: Logic change to prevent display of the “Line Diag” screen.
- **Symptom 9:** “LIST” soft touch key is not displayed on Bluetooth Audio screen while using

Bluetooth audio feature with an Apple device utilizing iOS8 software version.

Change: Logic change to enhance compatibility with iOS8 software.

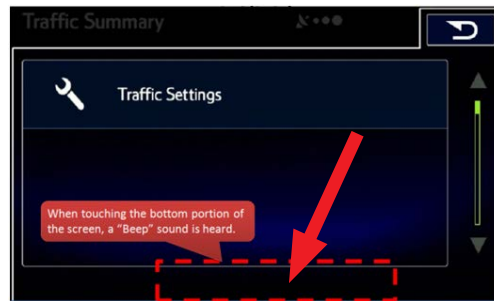
- **Symptom 10:** “Beep” sound heard when touching the bottom of the display screen where no function soft touch keys are displayed.

Change: Logic change to eliminate beeping sound from inactive soft touch key screen areas.

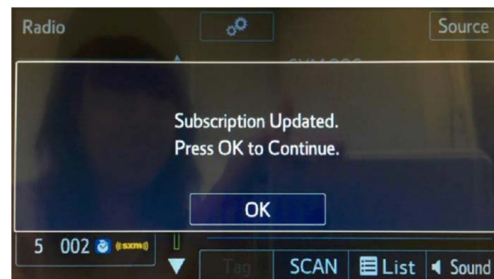
- **Symptom 11:** Sirius/XM caution message screen is displayed in English even when French language operation settings are selected.

Change: Logic change to make all messages display in the selected operating language.

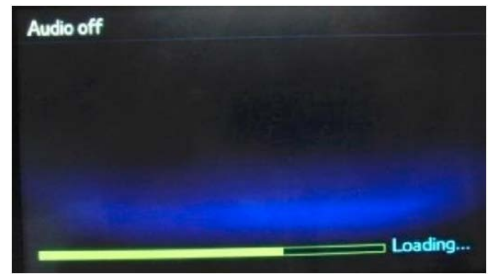
Loading Screen

- **Symptoms 12-16:** The following symptoms are all related to the inability of the software to properly load. One or all of these 5 conditions may occur at the same time. Logic changes have been included in the applicable update to address each of the following conditions:

- Repeated display of the “Loading” screen at initial unit start-up
- Bluetooth device pairing failure
- Inoperative steering wheel (satellite) switches
- Voice recognition feature inoperative
- Sirius/XM radio feature inoperative.
