SERVICE BULLETIN

APPLICABILITY: 2015-2016MY Legacy and Outback
 2015-2016MY Impreza and XV Crosstrek
 2016MY Forester
 2016-2017MY WRX
 2015MY BRZ

NUMBER: 15-199-16
DATE: 05/05/16

SUBJECT: Reprogramming File Availability to Address Operational Concerns with 6.2” Clarion Display Audio Unit

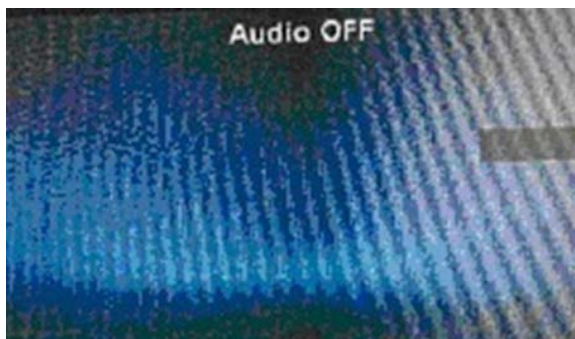
- Audio unit freezes and restarts when inserting and removing USB memory (flash drive).
- CD player stops playing audio and / or elapsed time display freezes.
- While talking on a paired phone and using the Bluetooth feature, audio unit restarts when shifting into Reverse.
- Audio unit restarts when receiving a Bluetooth phone call. The display goes black and may be accompanied by a “popping” sound.
- White stripes or streaks appear on the display as shown below.

This bulletin announces reprogramming file availability and the software installation procedure to address a group of operational concerns received from the field and listed below involving the Clarion Display Audio unit with 6.2” display. The procedure will involve downloading the applicable software update files from Subarunet then loading them onto a flash drive for audio unit installation.
