## REPAIR PROCEDURE

**APPLICABILITY:** 2016-2017MY Legacy and Outback  
**SUBJECT:** Inspection and Repair Procedure for Stop Sale / Recall Campaign  
 WTD-65: Steering Column

**NUMBER:** WTD-65R  
**DATE:** 05/10/16  
**REVISED:** 05/12/16

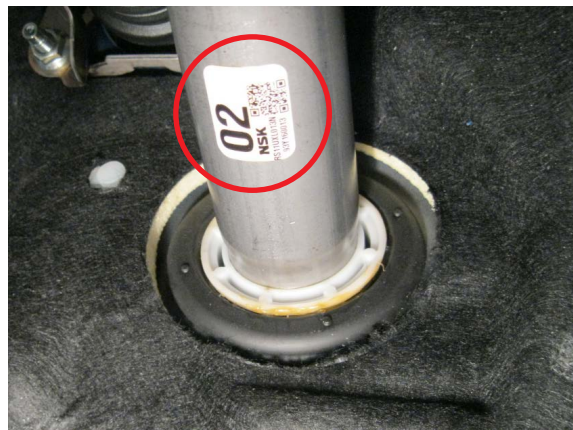
- Locate the lot number label at the base of the steering column located just above the toe board grommet as shown in the photo below.
