REPAIR PROCEDURE

APPLICABILITY: 2016-2017MY Legacy and Outback
SUBJECT: Inspection and Repair Procedure for Stop Sale / Recall Campaign
 WTD-65: Steering Column

NUMBER: WTD-65R
DATE: 05/10/16
REVISED: 05/17/16

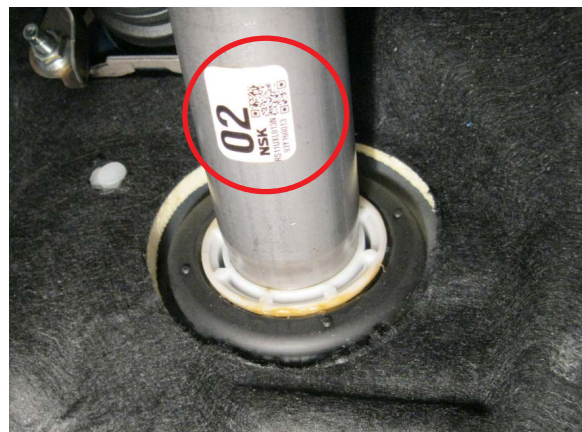
- Locate the lot number label at the base of the steering column located just above the toe board grommet as shown in the photo below.

For KEY START models, the label will have a large “02” as shown in the photo.
 For PUSH START models, the label will have a large “03”.

The steering columns are **NOT** interchangeable.

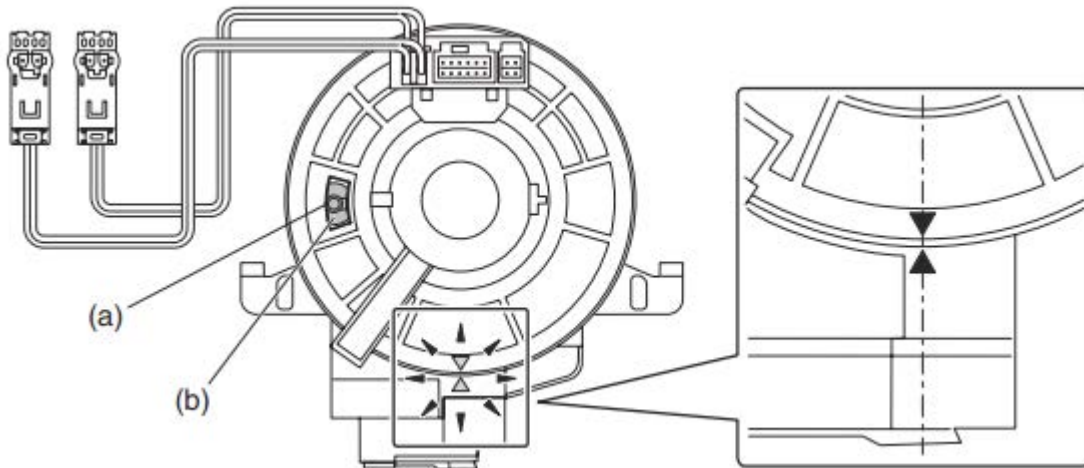
NOTE: When the roll connector comes to the center position, the orange roller (b) can be seen from the sight glass (a) as shown below.

- 1) Confirm the front wheels are positioned in straight ahead direction.
- 2) Rotate the roll connector counter-clockwise until it stops.
- 3) Rotate the roll connector clockwise approximately 2.5 turns until the “Δ” marks are aligned.
