REPAIR PROCEDURE

APPLICABILITY: 2016-2017MY Legacy and Outback
SUBJECT: Inspection and Repair Procedure for Stop Sale / Recall Campaign
 WTD-65: Steering Column

NUMBER: WTD-65R
DATE: 05/10/16
REVISED: 05/18/16

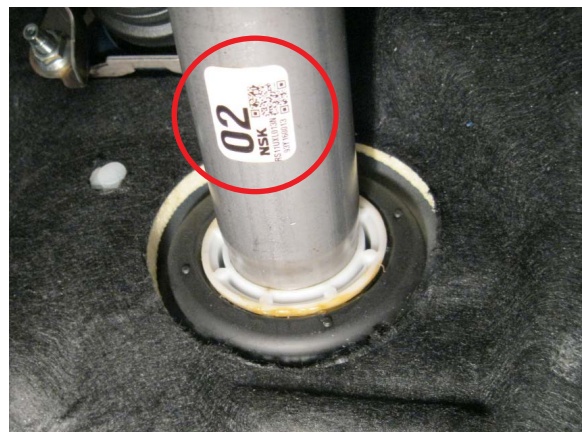
- Locate the lot number label at the base of the steering column located just above the toe board grommet as shown in the photo below.

For KEY START models, the label will have a large “02” as shown in the photo. For PUSH START models, the label will have a large “03”.

The steering columns are **NOT** interchangeable.
