## REPAIR PROCEDURE

**APPLICABILITY:** 2016-2017MY Legacy and Outback  
**SUBJECT:** Inspection and Repair Procedure for Stop Sale / Recall Campaign  
 WTD-65: Steering Column

**NUMBER:** WTD-65R  
**DATE:** 05/10/16  
**REVISED:** 05/11/16

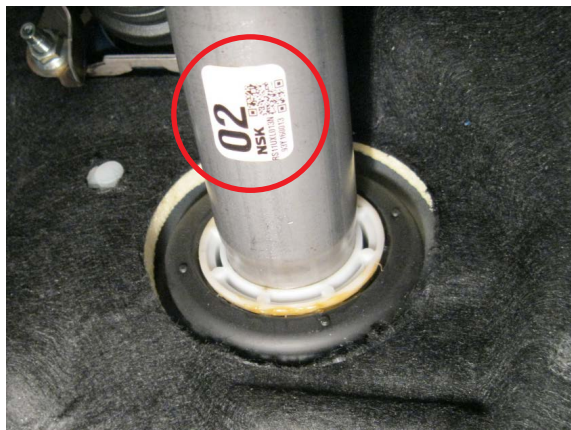
- Locate the lot number label at the base of the steering column located just above the toe board grommet as shown in the photo below.

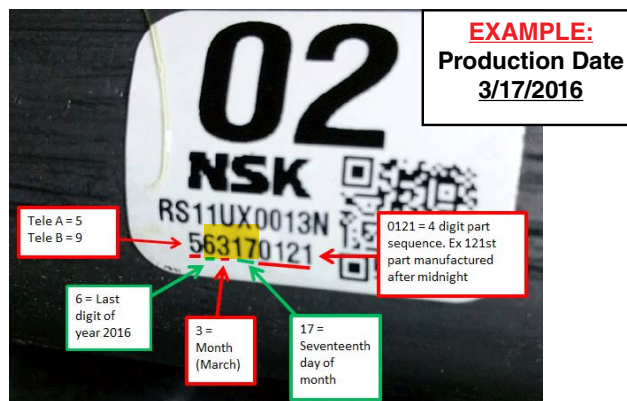
- Decode the lot number of the steering column using the illustration below.
- Affected steering columns will have a lot number label indicating the column was produced on or between 6228 (February 28, 2016) and 6416 (April 16, 2016), the steering column assembly must be replaced.
- If the lot number is illegible or otherwise cannot be determined, it must be noted on the repair order and the steering column assembly must be replaced.

- **IMPORTANT:** Always record the original lot number on the Repair Order even if it is outside the affected range. The ORIGINAL lot number must also be entered in the Miscellaneous Detail field when submitting for claim reimbursement. If illegible, enter “ILLEGIBLE” in that field.

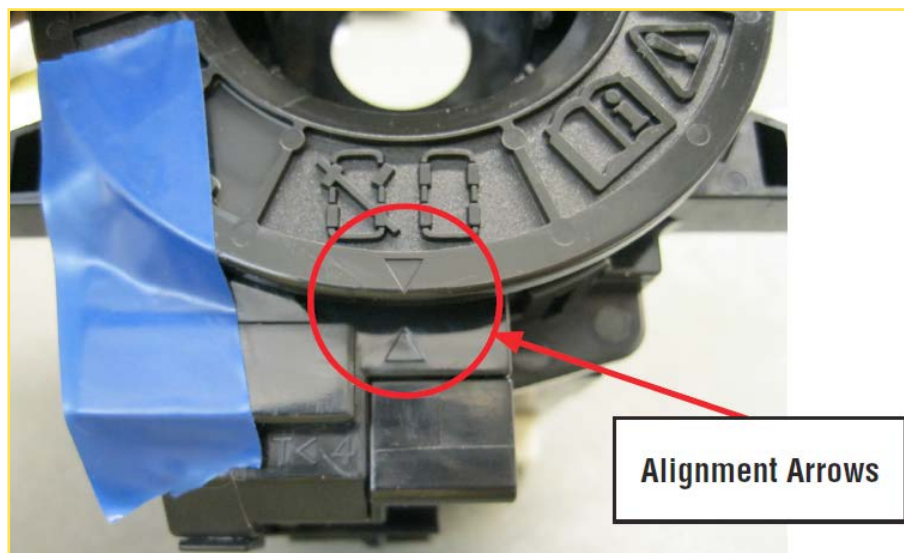
- After disconnecting all the wiring harness connectors, **CAREFULLY** remove the roll connector, steering angle sensor and the combination switch assemblies. **IMPORTANT:** Do not disturb the position of the roll connector while removed from the steering column. **As shown in the photo, use a piece of tape to keep it in alignment while removed.** **IF** the roll connector position is changed, the center position adjustment procedure provided below must be performed during reassembly.

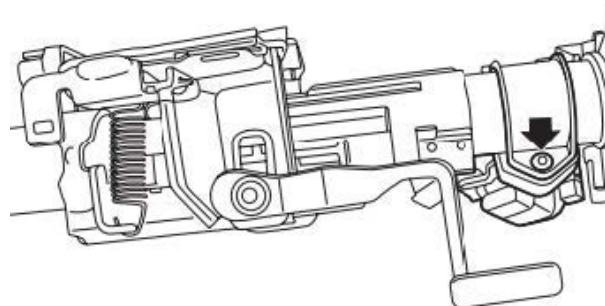
- **CAREFULLY** remove the steering column assembly taking special care to not dislodge the toe board grommet / bushing.
- Using a drill and screw extractor, remove the shear bolt securing the ignition lock to the steering column.

- **CAREFULLY** Install the new steering column taking special care to not dislodge the toe board grommet / bushing. Tighten the 2 retaining bolts to 20 Nm (14.8 ft. lbs.).

- Transfer the ignition lock to the new steering column and secure with the new shear bolt.
- **CAREFULLY** reinstall the combination switch, roll connector, and steering angle sensor assemblies. **REMINDER:** If the position of the roll connector was disturbed, the center position adjustment procedure outlined above must be performed.

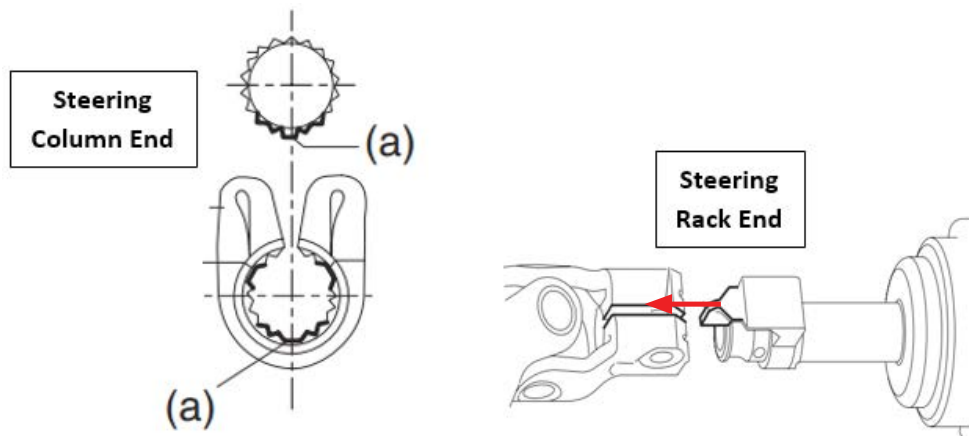
- Reinstall the universal joint shaft. Align the protrusion section (a) of the steering column shaft with the cutout (a) of the serration on the universal joint shaft as shown in the illustration on the left below. If not properly aligned, the upper bolt cannot be installed. Align the alignment mark on the steering rack end of the universal joint shaft with the mark on the steering rack input shaft and install the bolt but **DO NOT TIGHTEN IT**. The guide on the input shaft will slide into the split of the universal joint. Install the bolt and tighten to 24 Nm (17.7 ft. lbs.). Tighten the other bolt (on the column end) to 24 Nm (17.7 ft. lbs.).

**IMPORTANT:** Always tighten the steering rack end retaining bolt first.
