GROUP: Body

DATE: June 12, 2014

Sliding Door Trim Contacting Vehicle Rear Quarter

2008 - **2014**((RT)	Dodge Caravan
2008 - **2014**((RT)	Chrysler Town and Country

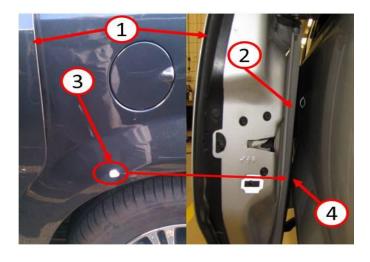
Fig. 1 Door Trim Contact

In some instances interior door panel to quarter panel contact has been noted on both left and right sides of the vehicle. Design clearances of the interior door panel are aggravated by heat which causes the door panel to relax and bow, which may contact the rear quarter panel (Fig. 1).

- 1 Sliding Door
- 2 Interior Door Trim Panel
- 3 Quarter Panel Contact Point
- 4 Panel Clearance Area

In order to correct this condition and avoid costly paint repairs, depending on production date, an additional retention point needs to be either added or engaged to prevent the door panel bowing condition. If the customer describes the symptom, perform the Repair Procedure.

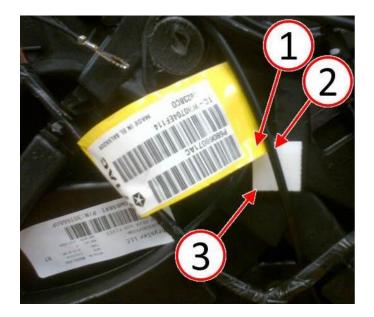
Fig. 11 Dual Lock Interference Conditions

- 1 Label
- 2 Cable
- 3 Dual Lock

- 1 Contact Point
- 2 Panel Clearance
- 3 Door Trim Panel
- 4 Quarter Panel
- 14. **Was door trim panel clearance to rear quarter panel (Minimum Gap is 3/16 in / 6 mm) specified in Step #13 achieved?
 - a. YES>>> Repair is complete. Return the vehicle to the customer.
 - b. NO>>> Remove one or both door trim panels that did not meet the clearance specification. Refer to the detailed procedures available in DealerConnect>TechCONNECT> under: Service Info> 23 Body> Doors Sliding> PANEL, Door Trim> Removal. Then inspect for any interference between the dual lock attachment point (3). Reposition and tape out of the way any cables (2) or labels (1) that may be interfering as shown in (Fig. 11). Then repeat Step #11 through Step #13.**
