NUMBER: 08-066-14

Flash: RE9 Radio Enhancements

This bulletin involves updating the radio and navigation software, if required.

2013-2014 (JC) Journey (China only)

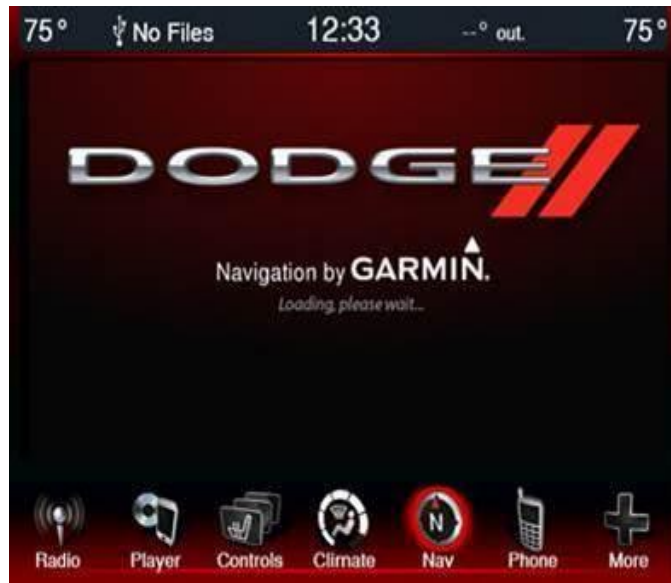
Fig. 1 System Loading Screen

1. Start the vehicle, turn the radio ON and allow it to power up.
2. Press the navigation screen button and attempt to access the navigation main menu screen.
3. Is the radio stuck on the “Loading Please Wait” screen? See (Fig. 1)
 - a. Yes <<< The radio will have to be replaced. Replace the radio using current electronic exchange center stock following normal warranty repair procedures. Refer to published service information in Tech Connect Section 08 - Electrical/8E - Electronic Control Modules/MODULE, Telematics Gateway/Removal. No further action is required, the bulletin is now complete. The replacement radio will contain the latest software update. Please use LOP 18-60-02-CD to close out the RRT portion of this bulletin.
 - b. No <<< Proceed to [Step #4](#) and perform the software update.

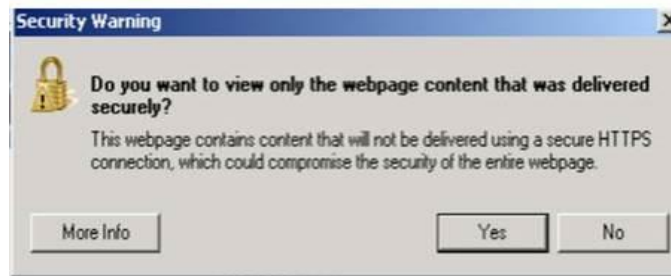
Fig. 2 Pop-up Security Message

4. Has a USB stick been created with the current software update?
 - a. Yes >>> Proceed to [Step #10](#).
 - b. No >>> Proceed to [Step #5](#).
5. Using Wi-tech, navigate to the Radio ECU details and record the ECU part number.
6. Go to DealerCONNECT>Service>UCONNECT Information & Utilities> Uconnect Dealer software downloads to download the files.
7. If a security message appears “Do you want to view only the webpage content that was delivered securely?” See ([Fig. 2](#)). Press **No** to continue.

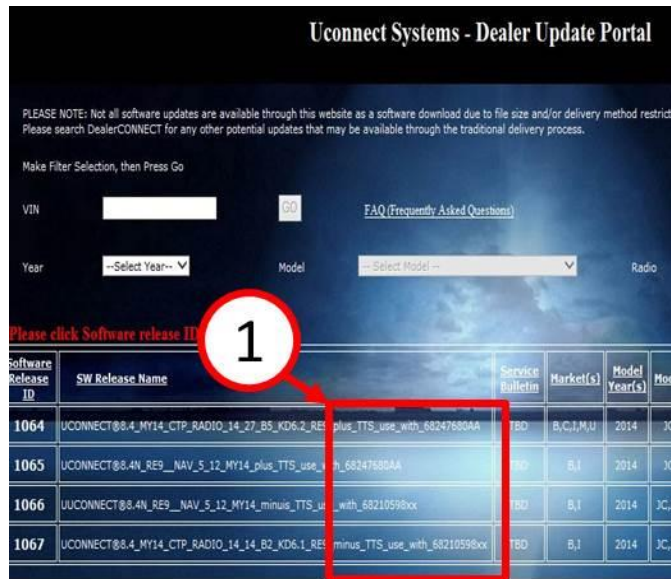
Fig. 3 Uconnect Main Portal Screen

- 8. If multiple files are available for the selected VIN, use the radio ECU part number recorded in [Step #5](#) to select the correct software packages. See ([Fig. 3](#)) and ([Fig. 4](#)) for the location of the part number information.

1 - Radio Part Number Location

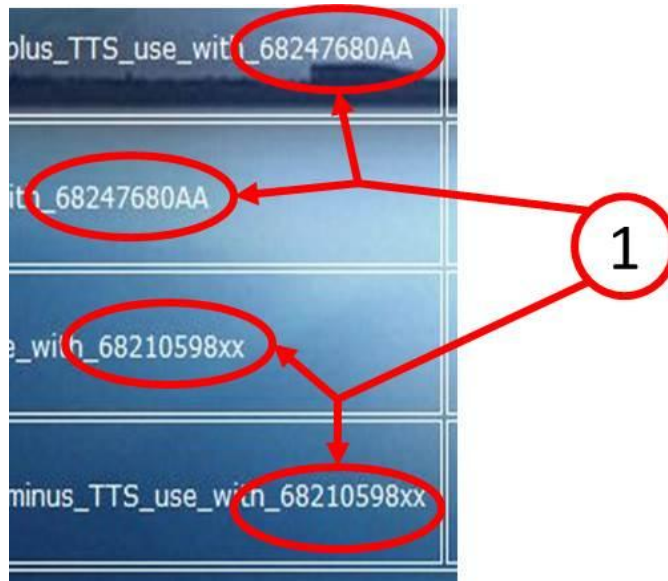
Fig. 4 Radio Software Selections

1 - Radio ECU Part Numbers

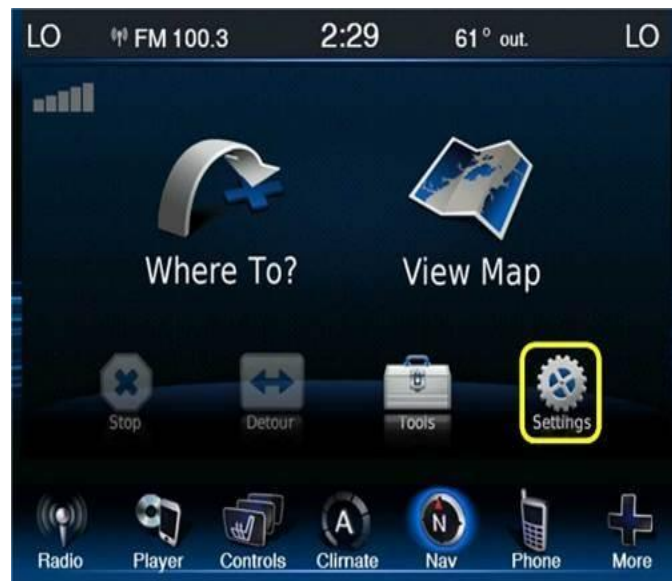
Fig. 5 Settings Icon

14. When the update is completed, the screen will read “Reflash Successful”. Touch the screen and the radio will reboot.
15. The screen will now show the current and new software levels. Verify if the new and current software levels are now the same and press no on the screen.
16. Remove the USB stick from the USB port and proceed to [Step #17](#)
17. From the navigation main menu screen, press the Settings screen button. See ([Fig. 5](#))

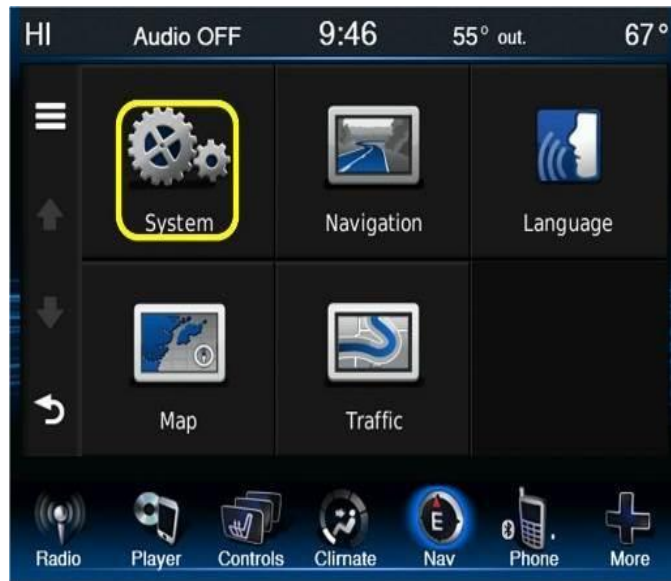
Fig. 6 System Icon

18. Press the System Icon. See ([Fig. 6](#))

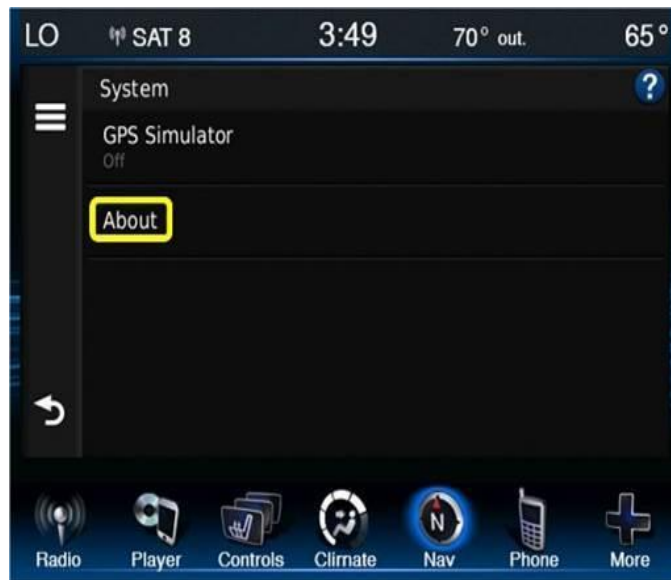
Fig. 7 About Icon

19. Press the About screen icon, see (Fig. 7), and record the software version.
