NUMBER: 23-026-14

Wind Noise At The Left And/Or Right Door

2014	(LC)	Challenger
2015	(LA)	Challenger

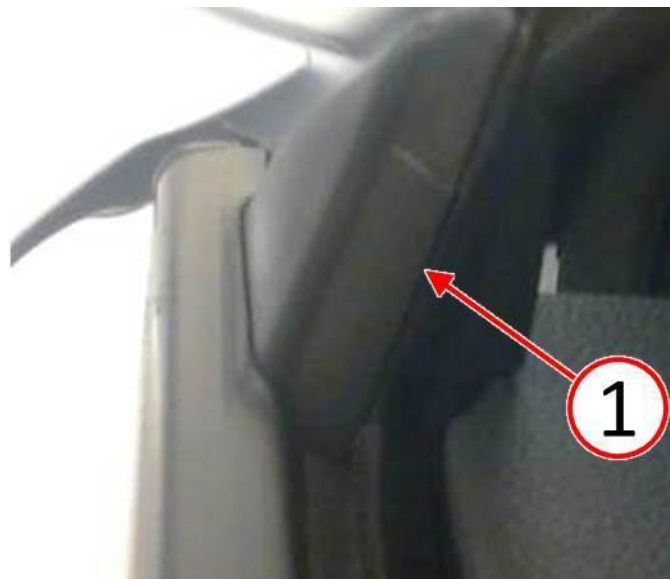
Fig. 3 Window Flag In Proper Position

1 - No Visible Gap

6. Raise the door window glass to the full up position.
7. Confirm that the gap has been eliminated between the outer door mounted window seal flag and the door window glass (Fig. 3).

8. If no gap is observed, confirm the customer's wind noise complaint has been resolved.
