# Technical Service Bulletin

GROUP	NUMBER
CAMPAIGN	18-01-017-1
DATE	MODEL
MAY, 2018	ACCENT (HC)

**SUBJECT:** HC ACCENT SPARK PLUG REPLACEMENT  
(SERVICE CAMPAIGN T2X)

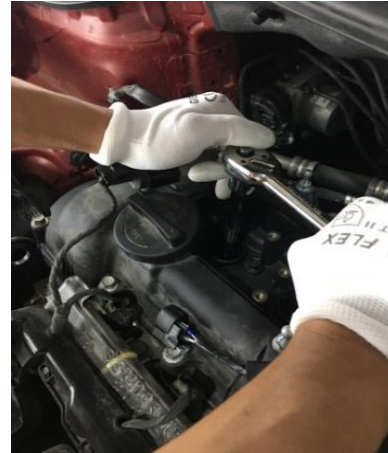
**Perform the below spark plug inspection of each plug as it is removed and identify any cylinders that have damaged plugs.**

- Remove each of the 4 spark plugs using a 16mm spark plug socket on a 3/8" ratchet and extension.

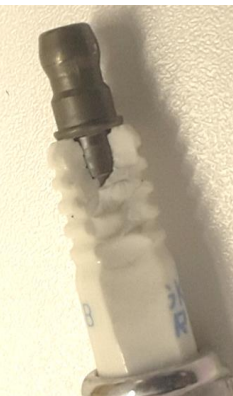
<p>Continue inspecting other plugs and if none are damaged with detached fragment(s) like the example below, then continue the TSB procedure to replace plugs and clear DTC.</p>
<p><b>Damaged with fragment(s) detached from the plug.</b></p>

<p><b>DO NOT START ENGINE. Contact Techline for further repair advice.</b> Identify affected cylinder(s) and take photo of the damaged plug condition to provide Techline to view severity of the plug condition and repair. <b>Note:</b> Fragment(s) may have fallen into the engine port(s) and may require special procedure to prevent engine damage.</p>

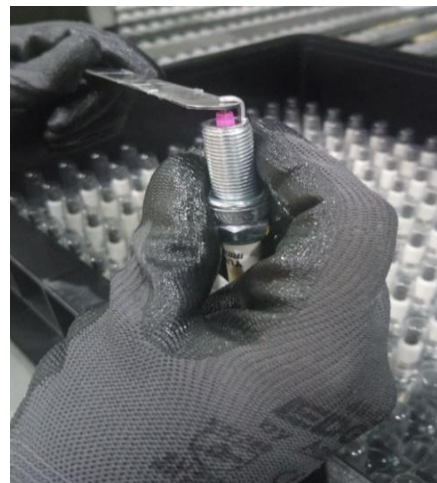
Inspect the electrode gap of all 4 new spark plugs using a gap gauge. Adjust as required to meet specifications.

Electrode Gap spec:  
0.9 - 1.0 mm  
(0.0354 – 0.0394 in)
