**SERVICE BULLETIN**

**APPLICABILITY:** 2017-18MY Impreza  
 2018MY Crosstrek  
 2018MY Legacy and Outback

**NUMBER:** 15-211-17R  
**DATE:** 06/13/17  
**REVISED:** 02/15/18

**SUBJECT:** Reprogramming File Availability for Additional Optimization of Harman Gen 3 Audio and Navigation Head Units

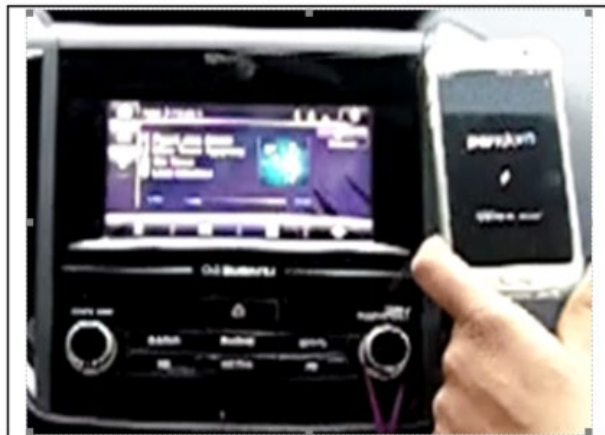
- 1- No streaming audio. When using the Pandora® app, there is no audio output.

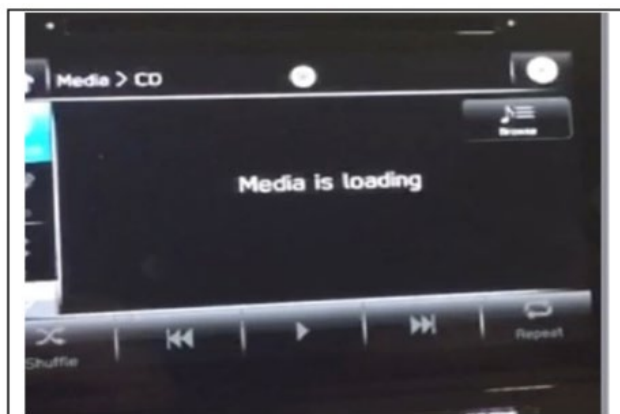
- 2- “Media is loading” is displayed on the screen but, the media never completes loading.

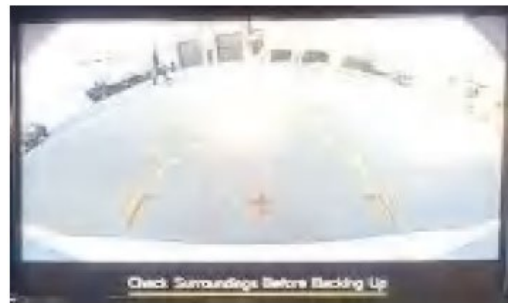
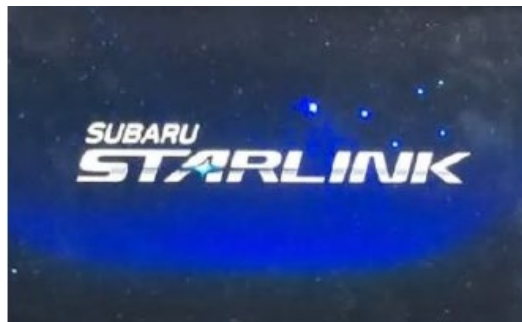
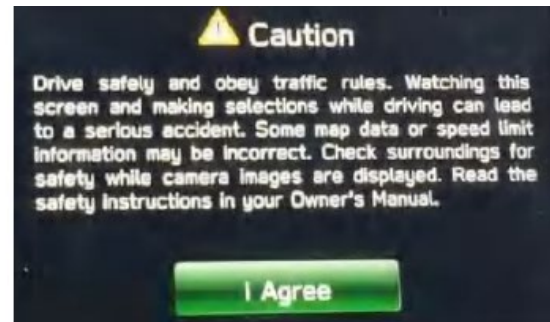
For reference, the previously released WTN-74R symptoms are also provided below. The main purpose of WTN-74R was to address display screen freeze-up during Back-Up Camera display (when the shifter is in “R”). In addition, the screen may also freeze when either the Subaru STARLINK or Disclaimer Caution / I Agree screen is displayed.

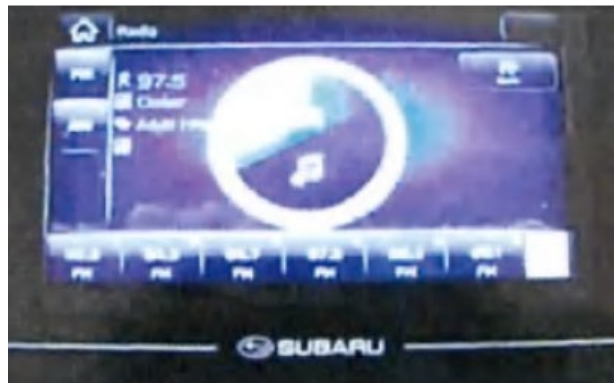
- 3) The time in the MFD automatically reverts to a “default” setting, even after setting the time using “Manual” mode.
- 4) Audio volume goes to maximum automatically after one click of the volume up button on the steering wheel. In some cases, this condition may also occur without input from the operator. Maximum volume is also displayed on the screen.
