SERVICE BULLETIN

APPLICABILITY: 2013-14MY Legacy and Outback Models with 2.5L FB Engines
 2011-14MY Forester Models with 2.5L FB Engines
 2015 MY Forester (Manual Transmissions Only) with 2.5L FB Engines
 2012-13 MY Impreza and XV Crosstrek Models with 2.0 FB Engines
 2014-15 MY Impreza and XV Crosstrek Models (Manual Transmissions Only) with 2.0 FB Engines

NUMBER: 02-157-14R
DATE: 08/28/14
REVISED: 04/13/16

SUBJECT: Engine Oil Consumption

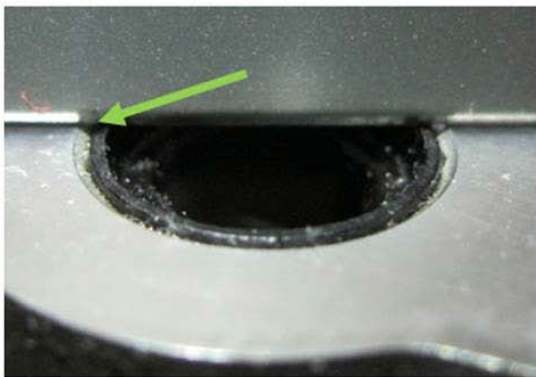
OK- Filter Screen flush with machined surface of camshaft carrier.

- **IMPORTANT:** If by chance the AVCS filter screens in the cam carriers have come loose, fallen out or become lost during disassembly, they are available separately (p.n. 14451AA050). **NOTE:** Although the filter screens are not directional, they must be installed flush with the machined surface of the cam carrier as shown in the OK photo below. The NG photo shows the screen installed too deep into the camshaft carrier. Engines with AVCS on both intake and exhaust will have 2 filters in each carrier as opposed to just one (intake only AVCS).

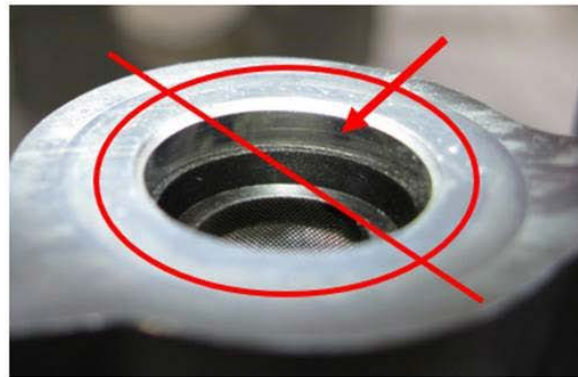
NG- Filter Screen installed too deep into the camshaft carrier bore.

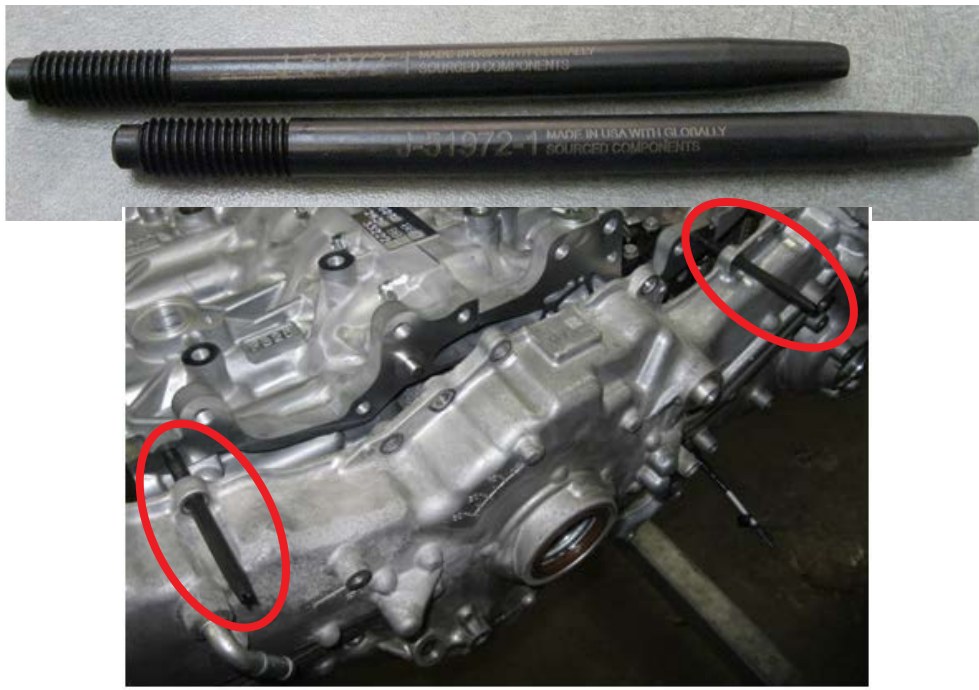
- IMPORTANT:** When re-installing the front cover assembly, be very careful to not allow it to contact any of the timing sprockets. If contact does occur, it will most likely be with the exhaust sprockets and it is almost a guarantee the fresh silicone sealer beads applied to the cover will be disturbed. To minimize the possibility of this happening, alignment pins as shown in the photos below have been developed to “guide” the cover into its proper position without disturbing the fresh sealer. The Subaru Special Tool number for the alignment pin kit is J-51972. Each kit includes 2 pins.

- If alignment pins are not used and the sealer gets disturbed during the cover installation, unless properly addressed, the affected area(s) will most likely be the source of an oil leak after reassembly. Don't hesitate to use a helper for the cover installation to prevent this from happening.
