SERVICE BULLETIN

APPLICABILITY: 2013-14MY Legacy and Outback 2.5L Models **NUMBER:** 11-145-14R
SUBJECT: Reprogramming File Availability for Oil Level Detection **DATE:** 09/15/14
REVISED: 04/21/16

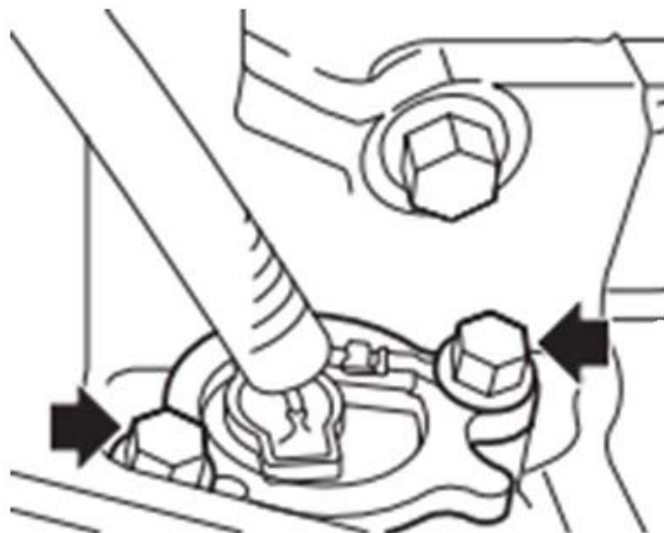
This bulletin announces the availability of reprogramming files and a revised oil level switch to optimize the ECM logic for engine oil level detection in the event of false or premature low engine oil level warning lamp illumination. Should a customer present a concern with a low engine oil warning lamp illumination and the diagnosis indicate the oil level is full or nearly full (oil level between the full and add marks/holes on the dipstick) and the customer has not added any engine oil, the ECM must be updated with this new logic and the oil level switch **specified below** replaced. The new oil level switch part number supplied in this bulletin must be used. If the customer has added oil, determine how much was added. Based upon the information provided, estimate where the oil level was when the lamp illuminated in order to determine if additional action is required beyond what is described in this bulletin (e.g an oil consumption test). The ECM must still be updated with this new logic and the oil level switch replaced.

Step 3 - Once the ECM reprogramming has been completed and the oil level switch wiring has been confirmed to be OK, proceed with replacing the oil level switch assembly shown in the illustration below following the procedure outlined in the applicable Service Manual. Torque the 2 retaining bolts to 6.4 Nm (56 inch-pounds). Torque the 2 retaining bolts to 6.4 Nm (56 inch-pounds).
