Air Injection System - Moisture Intrusion: MIL "ON" DTC P2440/P2442

YEAR(S)	MODEL(S)	ADDITIONAL INFORMATION
2012	Tacoma	WMI(s): 3TM, 5TF Body Type(s): Regular Cab, Access Cab, Extra Cab Transmission(s): MANUAL, AUTOMATIC Plant Code(s): -

Some 2012 model year Tacoma vehicles equipped with the 1GR-FE engine may exhibit a MIL "ON" condition with Diagnostic Trouble Codes (DTCs) P2440/P2442 (Secondary Air Injection System Switching Valve Stuck Open Bank 1/Bank 2). This condition may be caused by moisture intrusion into the air injection pump. Follow the Repair Procedure in this bulletin to address this condition.

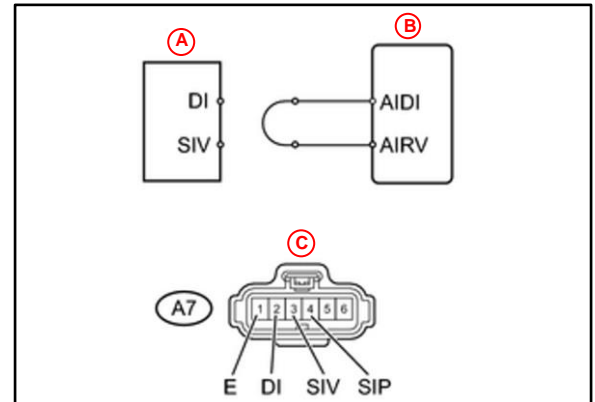
Figure 1.

2. Start the engine and warm it up to operating temperature, then turn the ignition switch OFF.
3. Disconnect the air injection control driver connector.
4. Connect terminals D1 and SIV of the wire harness connector for the air injection control driver.
