Service Information Bulletin

SUBJECT	DATE
SPN 521221 (TCM)	April 2017

2 SPN 521221/FMI 19

No CAN Communication

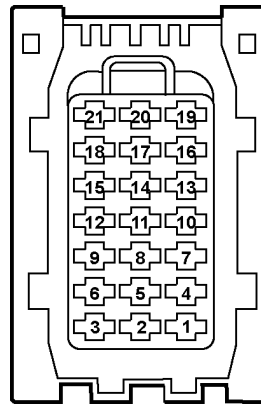
45801

6. Measure the voltage between TCM X1 21-pin connector pins 1, 2, 3, 4, 6 (ignition/battery voltage), and ground. Is the voltage less than 11.5 volts?
 - a. Yes; restore voltage to TCM X1 21-pin connector pins 1, 2, 3, 4, and 6.
