SUBJECT: **Detroit™ DT12™ Split Rod Bushing Repair**

Note: This document supersedes Technical Service Letter 16 TS-22.

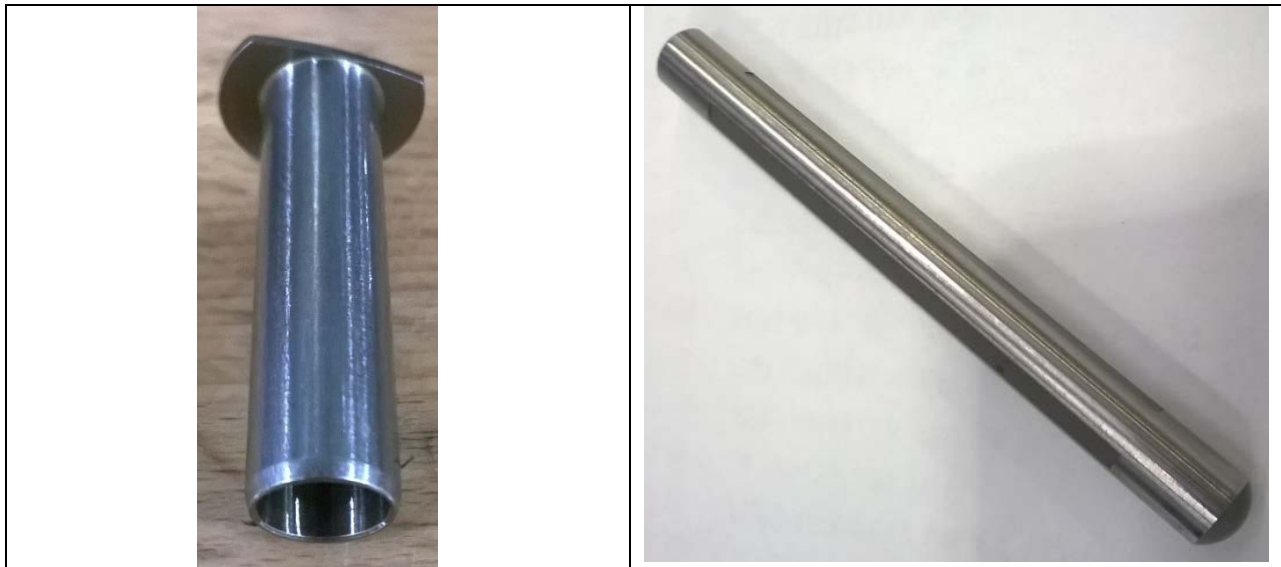
The steel split rod wears on the aluminum transmission housing, causing the split rod to stick. The Shift Controller cannot read the correct position of the split rod and will not shift into gear. To correct this, a hardened steel bushing and new design split rod with three flattened sides were implemented with transmissions built in August, 2016. For Detroit-built transmissions (transmission serial number beginning with 716), the change took place on August 9, 2016, with approximate transmission serial number 716310E0008107. For German-built transmissions (transmission serial number beginning with 715), the change took place on August 29, 2016, with approximate transmission serial number (last seven digits) 1806530. See Figure 1 for the new bushing and split rod.

Figure 1 – New Steel Bushing and Split Rod

Refer to new symptom-based diagnostics for a complaint of “Cold Gear Engagement” found in the *Detroit Transmissions Manual* (DDC-SVC-MAN-0140). The troubleshooting will indicate whether or not a split rod bushing repair is necessary.

The necessary parts to install the new bushing and split rod are contained in service kit P/N: A 960 268 23 74. The new kit is also shown in PartsPro in design group 342.

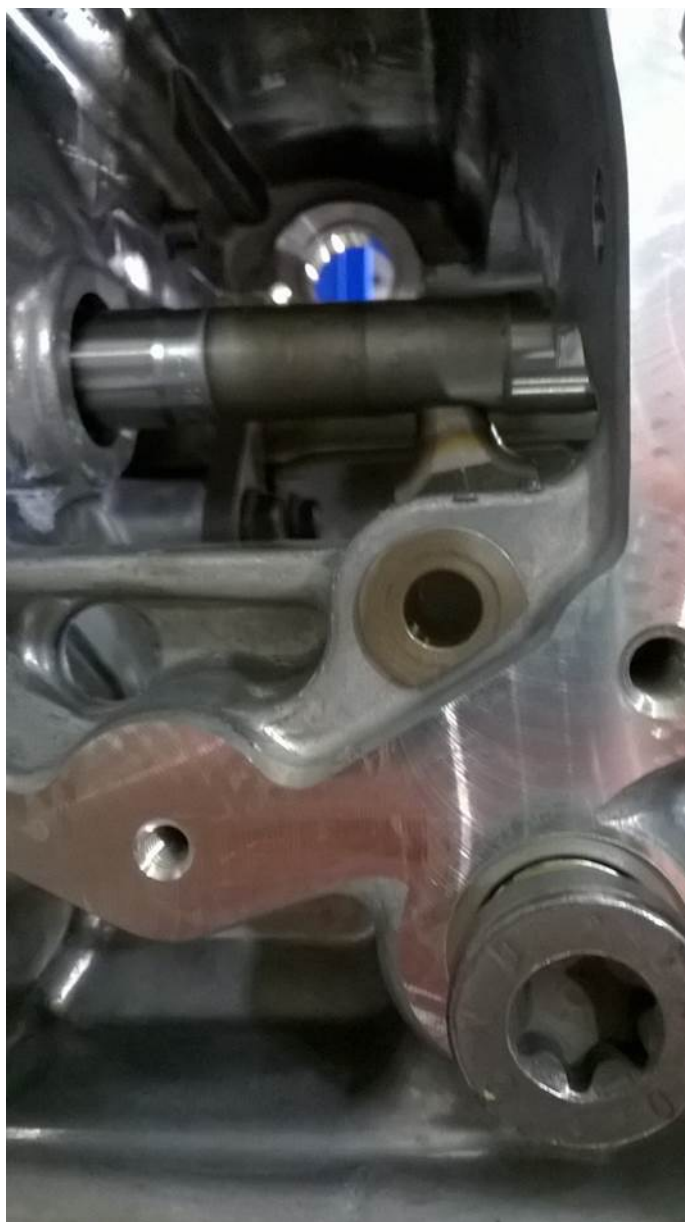
Figure 2 – New Steel Bushing Installed

In the *Detroit Transmissions Manual* (DDC-SVC-MAN-0140), reference the chapter titled “Internal Component Repair” and section “Split Rod Bushing Repair”. A supplemental video can be found on ddcsn.com. Go to Support, then Multimedia, then DT12 Transmission, then Split Pin Bushing Repair. See Figure 2 for the new bushing installed in a transmission. Note how the cut side of the bushing matches up with the transmission housing.
