November 2017  
FL741A  
NHTSA #17V-451  
REVISED NOTICE

## **Subject: FCCC XCR Chassis Battery Cables**

**Models Affected: Specific Freightliner Custom Chassis  
XCR chassis manufactured November 27, 2012, through  
February 23, 2016.**

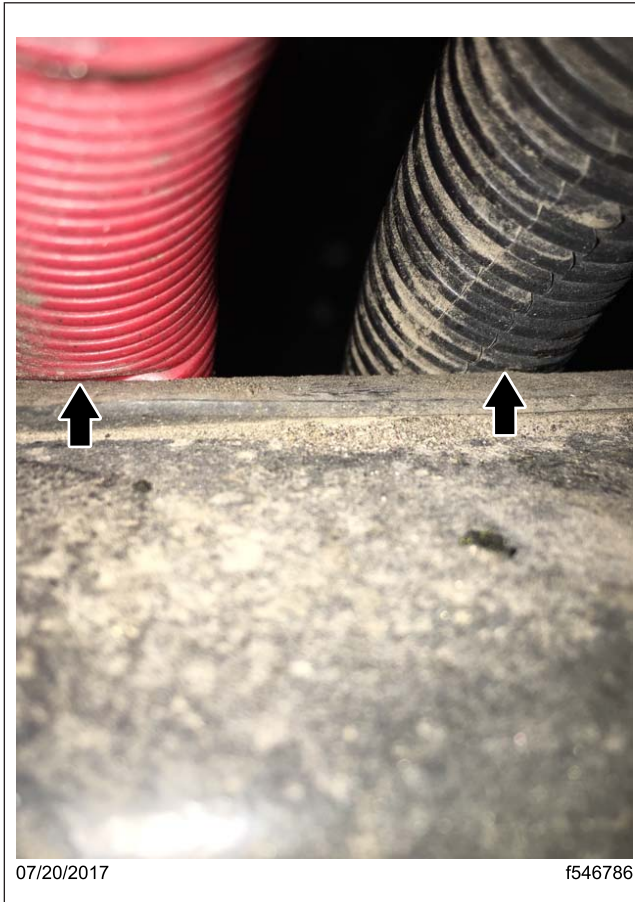
**Fig. 2, Battery Cables Rubbing the Frame Rail**

On certain vehicles a battery cable mounting bracket may have been incorrectly installed causing the battery cable to be improperly routed. If improperly routed, the battery cable may come in close proximity to the frame rail and cause rubbing or shorting of the cable. A potential battery cable short between the cable and the frame rail may increase the risk of a fire.

- If the battery cable bracket is incorrectly installed or missing, inspect the battery cables for damage. It is possible for the conduit that covers the cable to be damaged, but the battery cables are not damaged. Damage to the battery cables could include, but is not limited to, a cut in the battery cable or visible cable insulation. See [Fig. 2](#) and [Fig. 3](#). After inspection of the battery cable, go to 'Battery Cable Bracket Procedure.'

**IMPORTANT:** If the battery cable(s) are damaged, replace the battery cable(s). It is possible for the conduit that covers the cable to be damaged, but the battery cables are not damaged. Damage to the battery cables could include, but is not limited to, a cut in the battery cable or visible cable insulation. See [Fig. 2](#) and [Fig. 3](#)
