JTB00619NAS1

TECHNICAL BULLETIN

Hood Open Warning Displayed On The Instrument Cluster

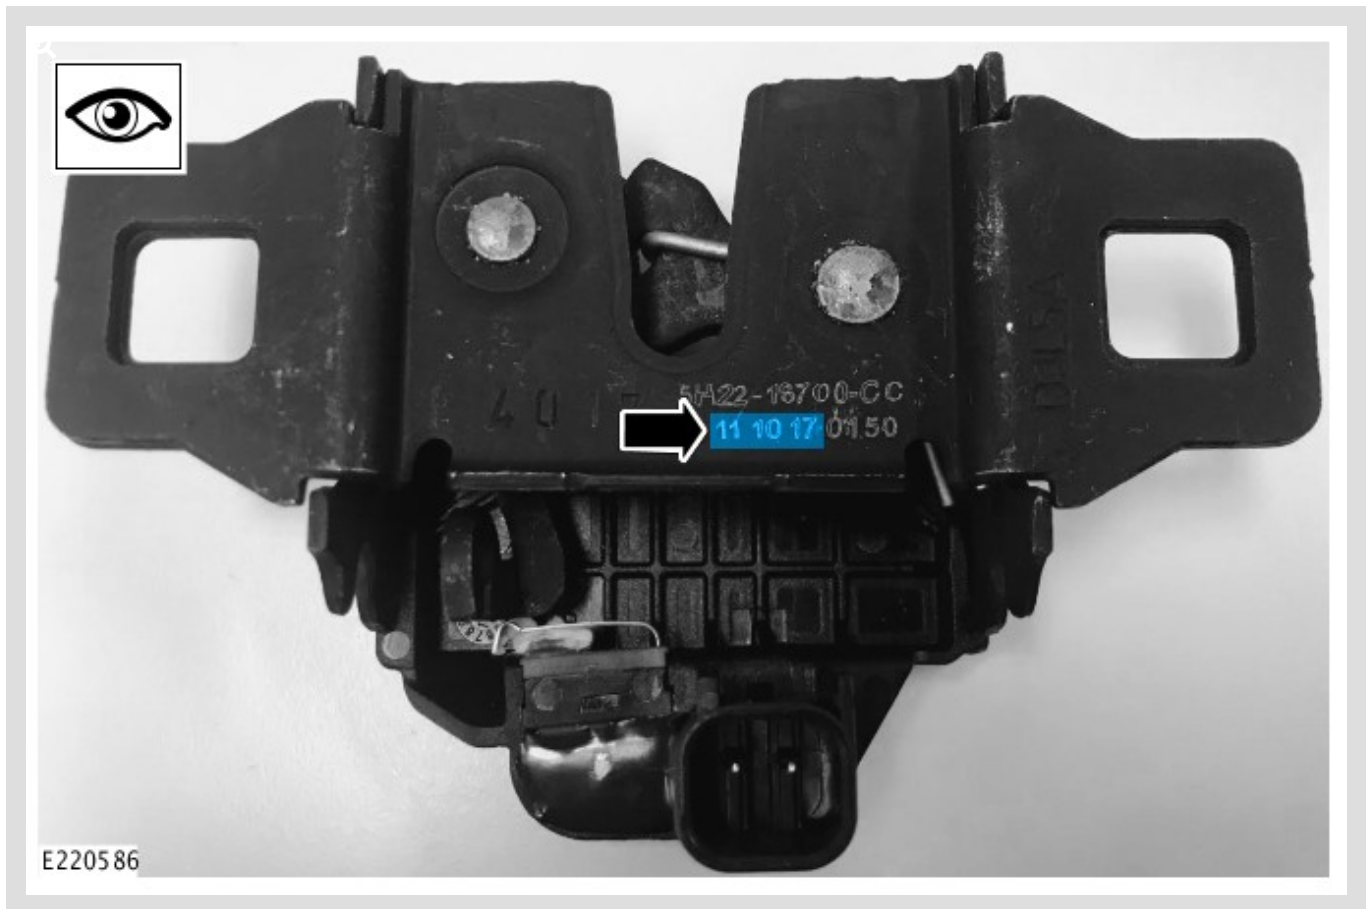
Date shown: 11/10/17 (11 October 2017).

The date code (DD/MM/YY) of the new hood latch must be **23/11/2017 (23 November 2017)** or later.

- 1 Replace the hood latch (see TOPIx Workshop Manual section 501-14: Handles, Locks, Latches and Entry Systems - Removal and installation - Hood Latch).
