H059NAS1

TECHNICAL BULLETIN

303-01A: Engine - INGENIUM I4 2.0L Diesel

Service Action: Balancer Shaft Whine

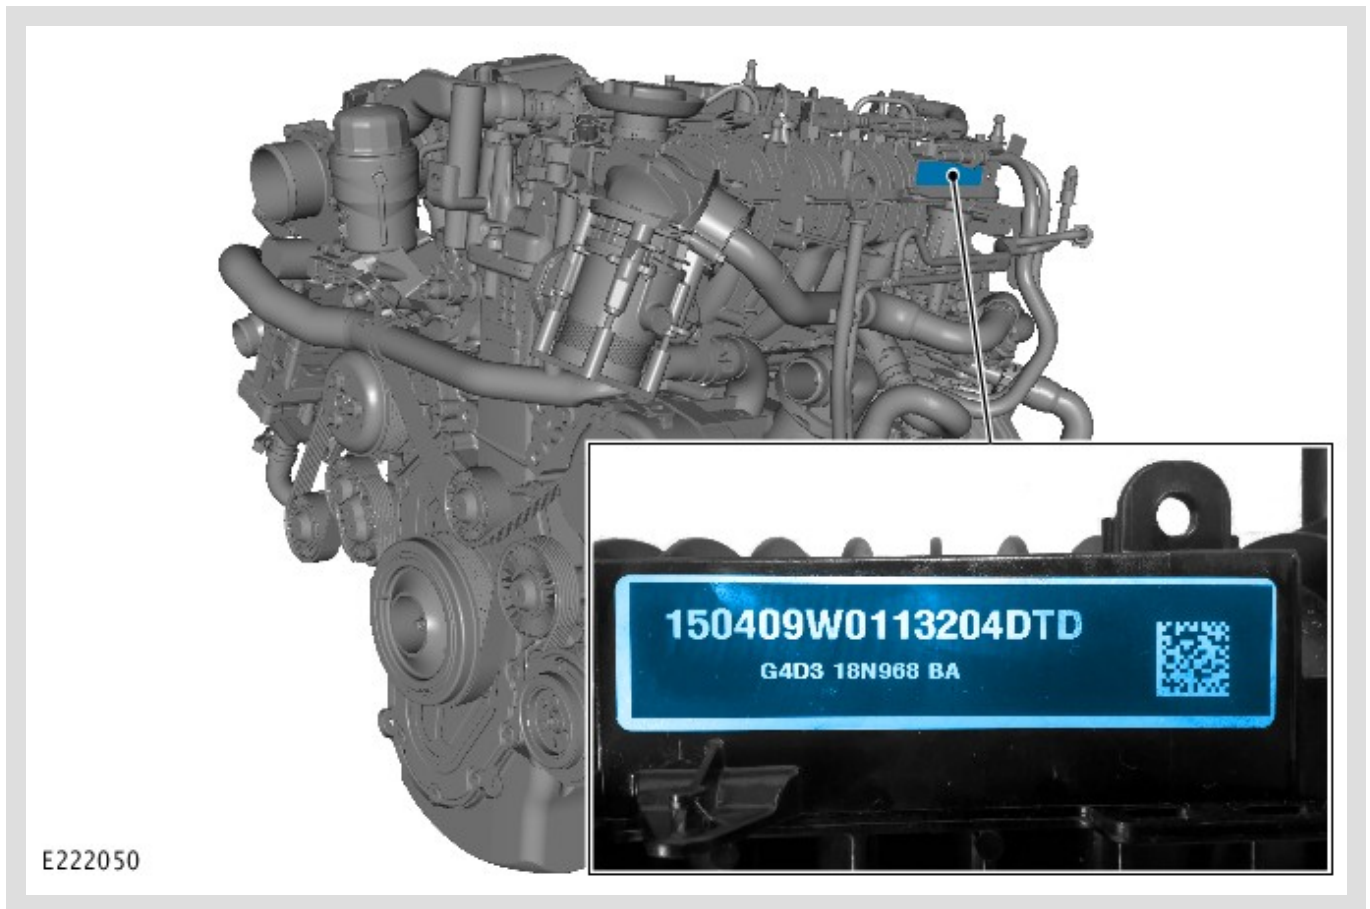
1

The engine build date is the first 6 characters (YY/MM/DD) of the engine serial number.

Locate and record the engine serial number.

- If the engine build date (first 6 characters of the engine serial number) is after **170817W0976204DTD** (2017 August 17), do not continue with this Workshop Procedure.
 - Submit a Technical Assistance (TA) request for further assistance.
- If the engine build date (first 6 characters of the engine serial number) is before **170817W0976204DTD** (2017 August 17), go to Step 2.
