NA_MACK_Vehicle_Range

NA_VOLVO_Vehicle_Range

Title (customer effect) Oil Contamination Of The Clutch Due To Rear Crankshaft Adaptor O-ring Leakage - Oil Leak At Clutch And Flywheel Housing; Possible Burnt Clutch Smell And/Or Clutch Slipping; Possible Customer/Initial Report Of Crankshaft Rear Main Seal Leak - **OBD13 And Newer (16-Pin Diagnostic Connector)**

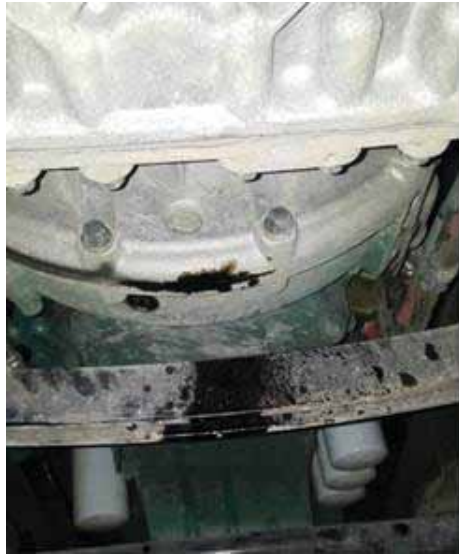
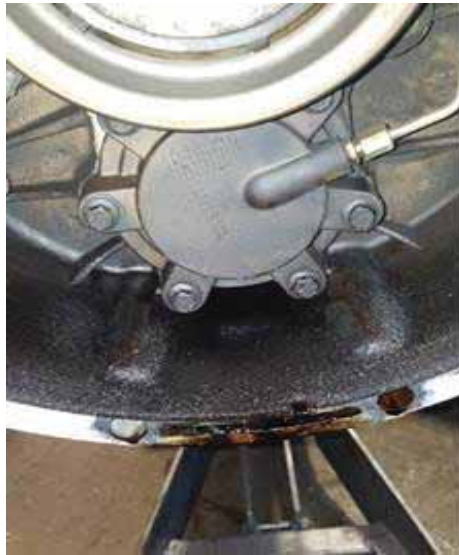
Cause Vehicles may present with oil leak coming from the clutch/flywheel housing and observation of burned clutch smell or clutch slipping. These symptoms can be mistaken as a crankshaft rear main seal leak.

The o-ring that seals the rear crank gear flange to the crankshaft can leak oil into the cavity on the rear of the crank. This oil builds up and leaks out under the bolt heads of the flywheel and contaminates the clutch. The oil in the flywheel/clutch housing will be black like engine oil and the evidence of the leak will be all the way around the housing due to the oil being slung out of the clutch assembly. When the source of the leak is the crankshaft rear main seal or a transmission seal, oil will run down the face of the engine or the transmission and pool in the bottom of the housing. Oil will not be distributed all the way around the housing as it would from the rear crank gear flange o-ring.

Engine Oil Accumulation in Bottom of Flywheel Housing

A. This repair will require the removal of the flywheel housing in order to remove the rear crank flange adaptor and replace the o-ring. An exploded diagram showing the o-ring can be seen below:

B. The clutch and pressure plate need to be replaced.

C. The flywheel should be cleaned and inspected, then resurfaced or replaced as necessary.

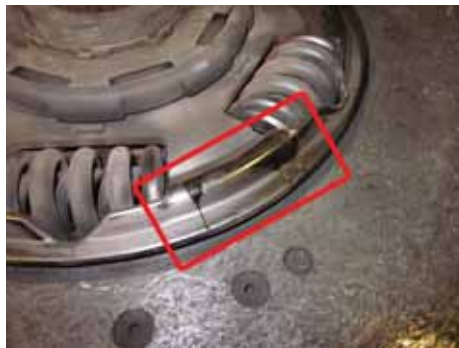
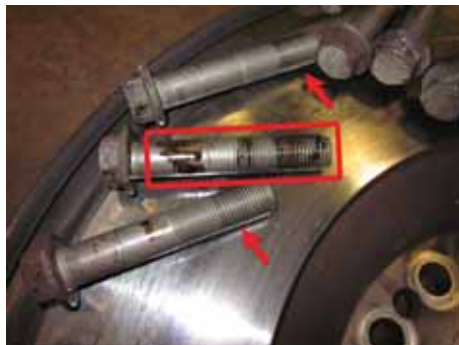
Engine Oil on the Clutch Disk and Flywheel Bolt threads

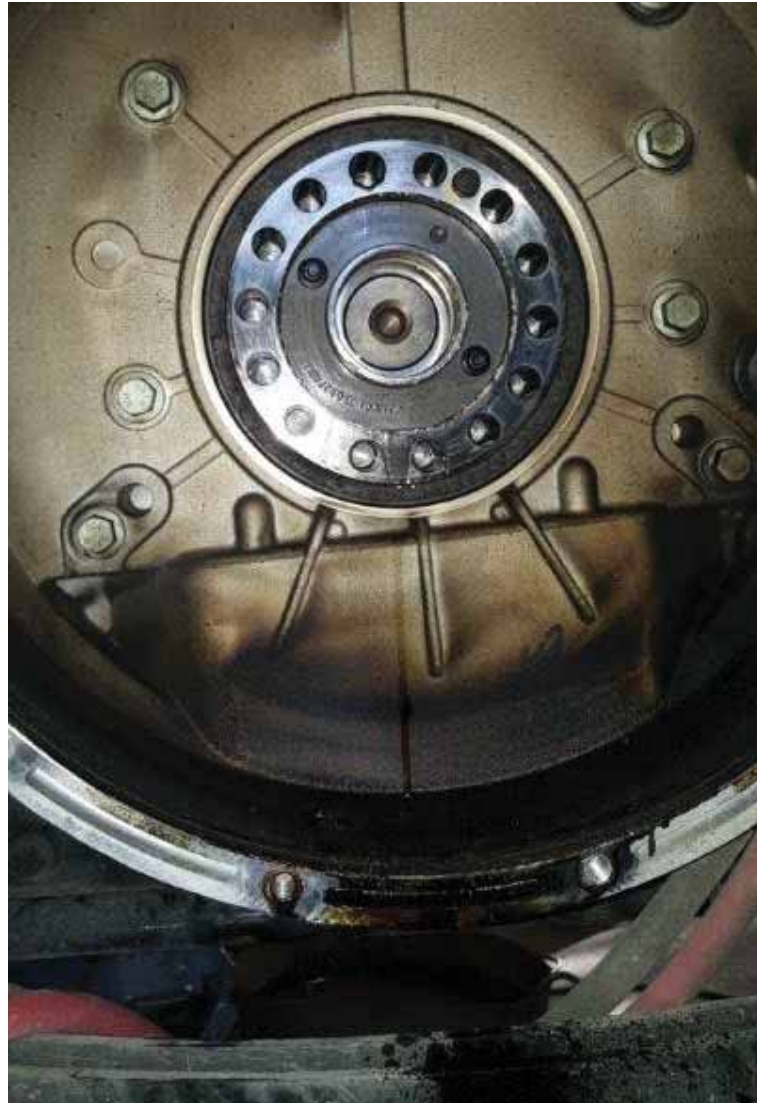
Engine Oil Leak - Not from Main Seal - Note that there is no oil path visible from the bottom of the crank flange down the face of the housing to the visible buildup

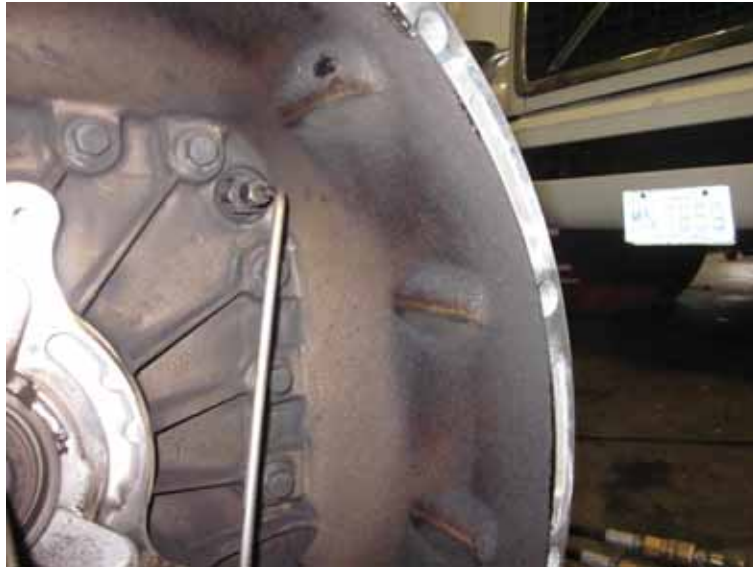
Oil Film visible on inner circumference of the Clutch Housing

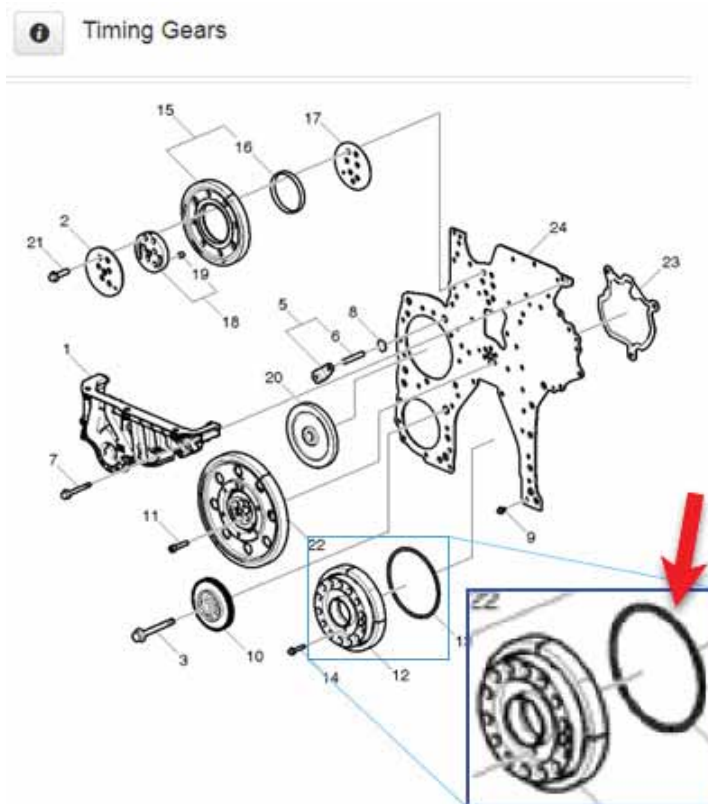
Note that the O-ring is located under the Timing Gear assembly in Impact, not the Crankshaft assembly.

- The procedure for flywheel housing removal and reinstallation can be found in the Service tab of Impact, Operation [2125-03-02-03 Flywheel Housing, Replacement](#).
