Technical Service Bulletin

Technical Service Bulletin: TSB150006	Released Date: 01-May-2018
Leaking Diesel Exhaust Fluid (DEF) from the Aftertreatment DEF Dosing Unit Electrical Connector

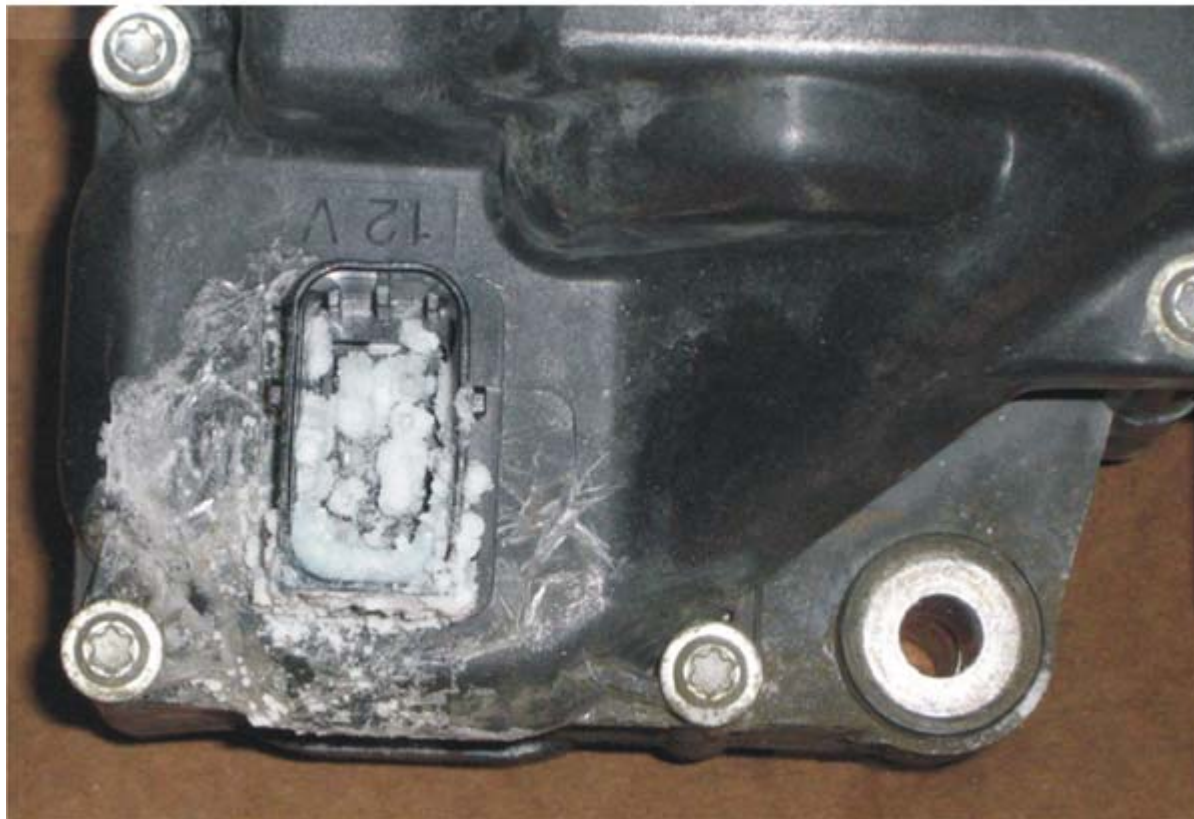
- Diesel exhaust fluid (DEF) can freeze, causing the aftertreatment DEF dosing unit electrical connector to crack and leak DEF.

- Use the appropriate fault code troubleshooting tree to confirm and troubleshoot the corresponding fault codes. See the corresponding Fault Code Troubleshooting Manual.
- During the troubleshooting process, look for evidence of leaking DEF around the aftertreatment DEF dosing unit electrical connector. See Figure 1 below.

If DEF is found leaking around the aftertreatment DEF dosing unit electrical connector, replace the aftertreatment DEF dosing unit. See the corresponding Service Manual. Reference Procedure 011-058 in Section 11.
