Technical Service Bulletin: TSB180042	Released Date: 07-May-2018
Heat Exchanger Mounting Bracket Installation

- ISL9 CM2350 L101
- L9 CM2350 L116B
- L9 CM2350 L123B
- ISL G CM2180
- L9N CM2380

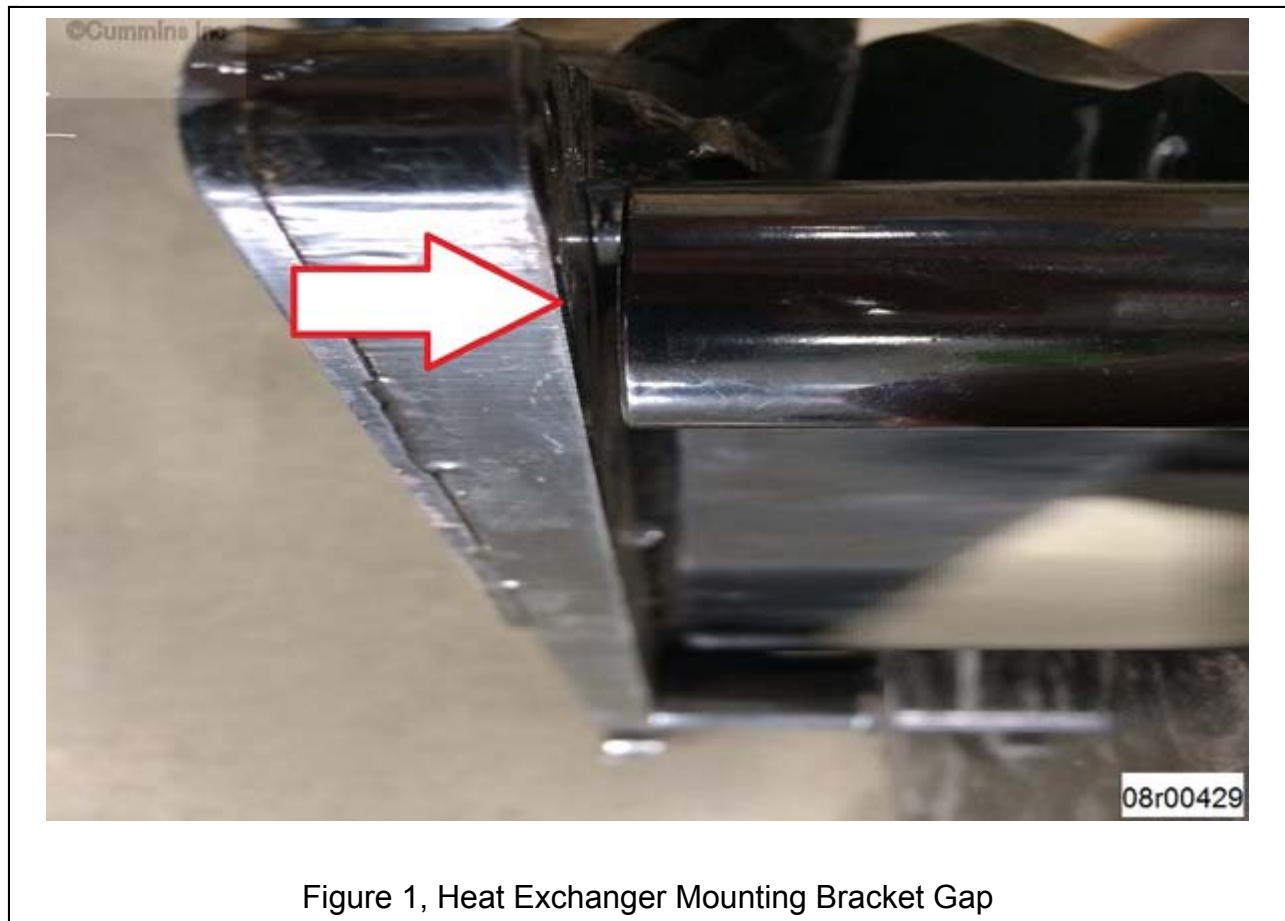
Figure 1, Heat Exchanger Mounting Bracket Gap

Heat exchanger mounting bracket, Part Number 5289017, has gaps when mounted to engine.

Incorrect initial assembly procedure.

Inspect for gaps at heat exchanger mounting bracket mounting points as indicated by Figure 1.

If gaps are identified loosen all mounting capscrews and follow the torque procedure below:

1. Torque bottom two mounting screws to 43 n•m [32 ft-lb], working from front to rear of engine.
2. Torque top mounting screws to 43 n•m [32 ft-lb], working from front to rear of engine.
