MODEL
2017MY
Niro (DE HEV)

NUMBER
PS553 (Rev 1, 05/15/2018)

SUBJECT: HEV WARNING LIGHT AND DTC P1B25/P1B77

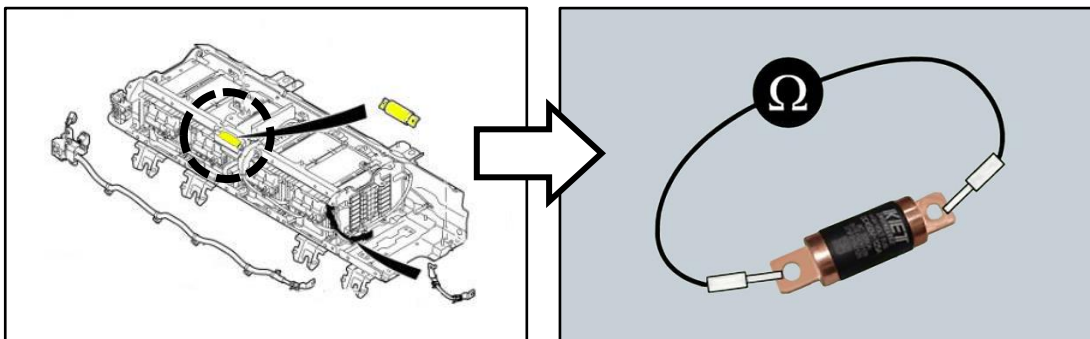
Hi-Voltage Battery Fuse

When addressing a concern related to the Niro HV warning light ON, and KDS detects a primary DTC P1B25 (HV Path Fault) and secondary DTC P1B77 (HV Pre-Charge Fault), then the 125 Amp High Voltage Battery Fuse should be inspected for an intermittent and/or an open condition.

Measure the resistance while tapping on the fuse (less than $<1\Omega$ resistance).

Specification: 1Ω or less (68°F)

If the measured resistance is not within specification, or the P1B25 DTC is intermittent, replace the 125 Amp main HV battery fuse with the newer 175 Amp main HV battery fuse.
(Part # 375F2 A8170)
