GROUP Electrical	MODEL 2017-2018MY See List Below
	NUMBER PS564	DATE May 2018

SUBJECT: CLOCK CONCERNS ON UVO eSERVICES (UVO 3.0)

This Pitstop contains information regarding possible concerns with the clock on UVO eServices (UVO 3.0) head units installed on 2017-2018MY vehicles.

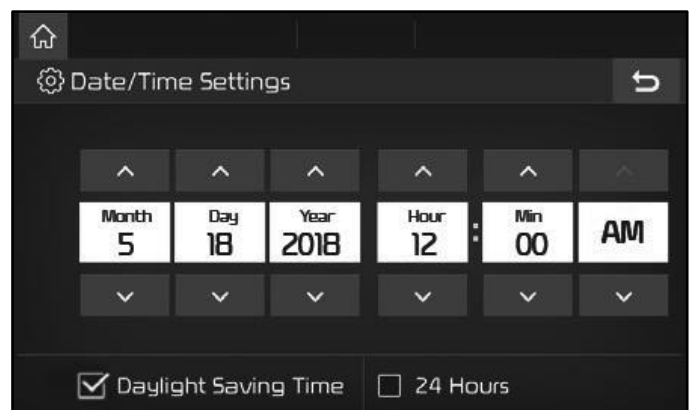
“GPS date and time” on the UVO 3.0 will not get “picked up” automatically on a new vehicle or after a loss of power to the head unit. It is necessary to set the date and time in an area with strong GPS reception:

From the **Home** screen, select **Setup** → swipe the screen to the left → **Date/Time** → adjust date and time using the up or down arrows.

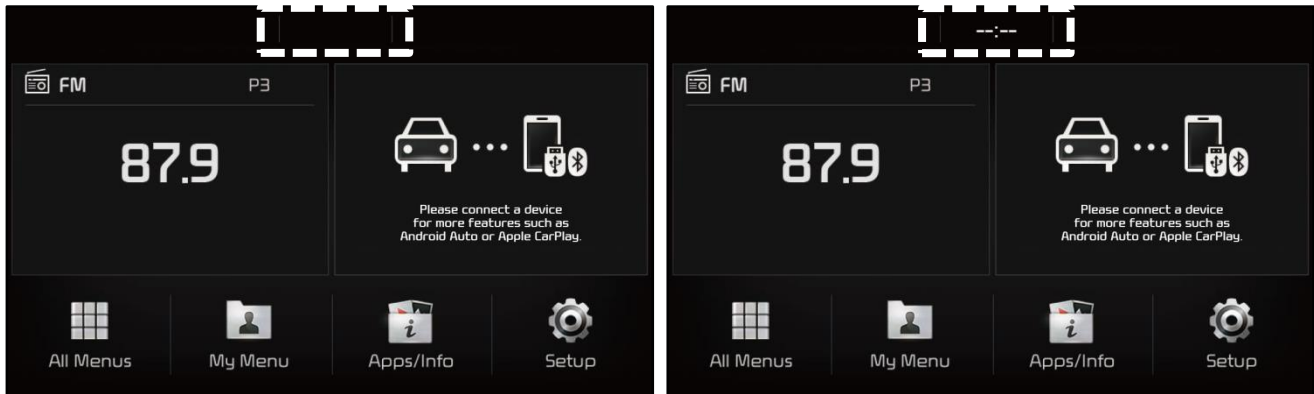
If no time is shown (area is blank) or there are dashes where the time should be, check the following:

1. Confirm vehicle has been driven in an open area and time is still not shown.
2. Measure the voltage on the center terminal of the coaxial connection at the antenna base connector on the harness side with the radio and ignition on (spec: 5V to 6V).
3. If the voltage is not within specification, confirm the blue GPS connector is connected properly to the back of the head unit and that the pin is not bent or damaged, and continue to check circuit integrity from head unit to the antenna.
4. If voltage is within specification, consider a head unit replacement.
