SERVICE BULLETIN

EC18-012

May 17, 2018

2016 TITAN XD; MIL ON WITH DTC P0420

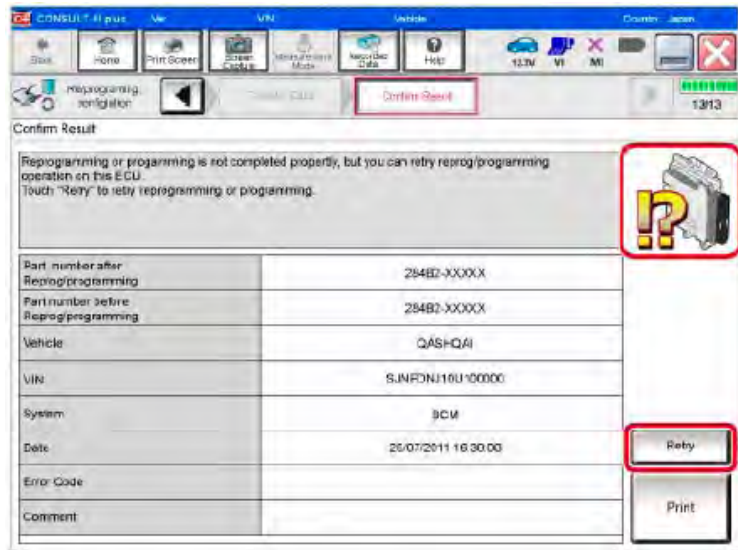
Figure 5

If reprogramming does not complete and the “!?” icon displays as shown in Figure 5:

- Check battery voltage (12.0 - 15.5 V).
- Ignition is ON, engine OFF.
- External Bluetooth® devices are OFF.
- All electrical loads are OFF.
- **Select retry and follow the on screen instructions.**
- “Retry” may not go through on first attempt and can be selected more than once.

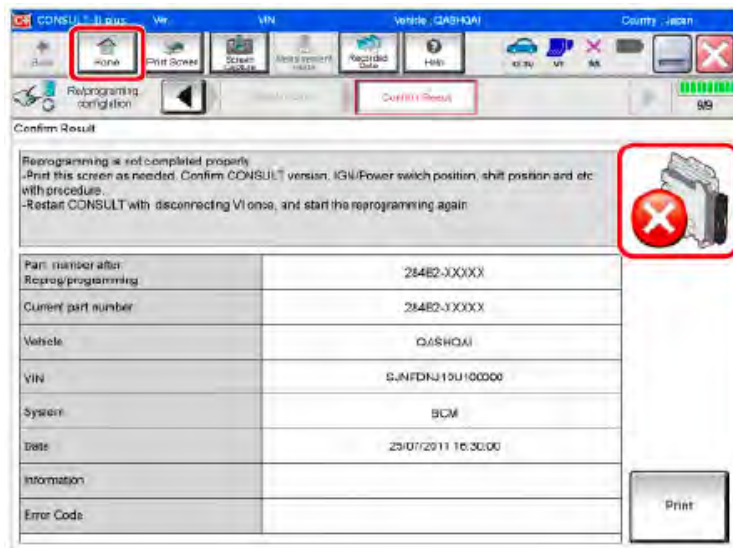
Figure 6

If reprogramming does not complete and the “X” icon displays as shown in Figure 6:

- Check battery voltage (12.0 - 15.5 V).
- CONSULT A/C adapter is plugged in.
- Ignition is ON, engine OFF.
- Transmission is in Park.
- All C-III plus / VI cables are securely connected.
- All C-III plus updates are installed.
- **Select Home, and restart the reprogram procedure from the beginning.**
