Secondary Air Injection System - MIL "ON" DTC P2440, P2442, and/or P2445 (1GR-FE)

YEAR(S)	MODEL(S)	ADDITIONAL INFORMATION
2012	Tacoma	WMI(s): 3TM, 5TF Body Type(s): Access Cab, Extra Cab Transmission(s): 5AT, 6MT

Some 2012 model year Tacoma vehicles equipped with the 1GR-FE engine may exhibit a MIL "ON" condition with the following Diagnostic Trouble Codes (DTCs):

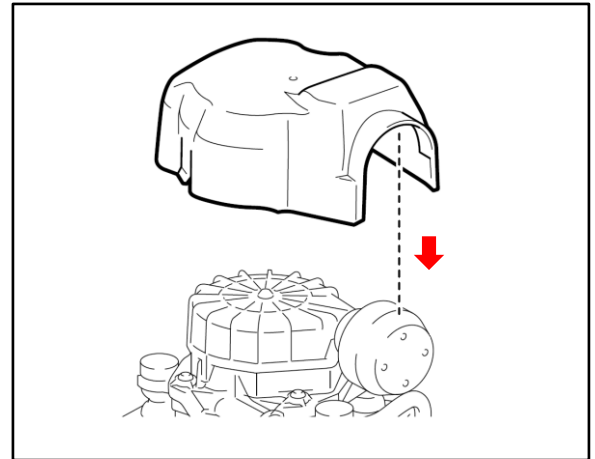
Figure 1.

Air pump cover installation will reduce the possibility of filter damage.

- B. Install the air pump cover.

- (1) Place the air pump cover over the air pump, making sure to follow the contours of the air pump.
- (2) Apply downward pressure until a click is heard.
- (3) Confirm the air pump cover is fully seated.
