Service Campaign Bulletin

Mercedes-Benz

Campaign No. 2018030013, April 2018

SUBJECT: **Model 906 Model Year 2016**
Check Pressure Regulating Valve

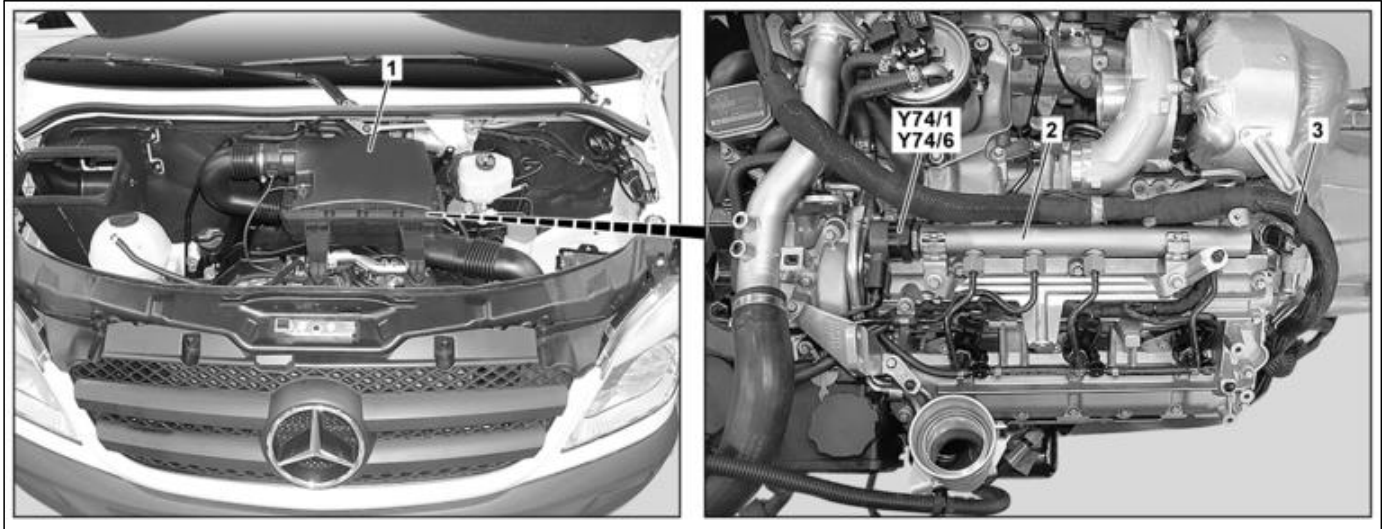
1 Air cleaner housing
2 Rail

3 Engine wiring harness
Y74/6 Pressure regulator valve

2.	Remove air filter housing (1)	
3.	Check pressure regulating valve (Y74/6) for leak tightness	<p>To do so, disconnect electrical connector from pressure regulating valve (Y74/6).</p> <p>Any internal leakage will be visible in the form of diesel fuel in the electrical connector. If there is no diesel fuel in the electrical connector of the pressure regulating valve (Y74/6). ↓ No measure necessary. Proceed with operation step 5. If there is diesel fuel in the electrical connector of the pressure regulating valve (Y74/6). ↓ Proceed with operation step 4.</p>

4.	Check electrical connectors of the CDI control unit (N3/30) for the presence of any diesel fuel	<p>To do so, disconnect electrical connectors from CDI control unit (N3/30). If diesel fuel is not present in the electrical connectors of the CDI control unit (N3/30). ↓ Replace engine wiring harness (3) and rail (2). If diesel fuel is present in the electrical connectors of the CDI control unit (N3/30). ↓ Replace CDI control unit (N3/30), engine wiring harness (3) and rail (2).</p>
