December 2016
FL727AB
NHTSA #16V-809
SECOND REVISED NOTICE

Subject: FCCC Motorhome Power Steering Hose Routing

Models Affected: Specific Freightliner Custom Chassis XBR, XCL, XCM, and XCR chassis equipped with Cummins ISL engines, and manufactured January 1, 2016, through October 13, 2016.

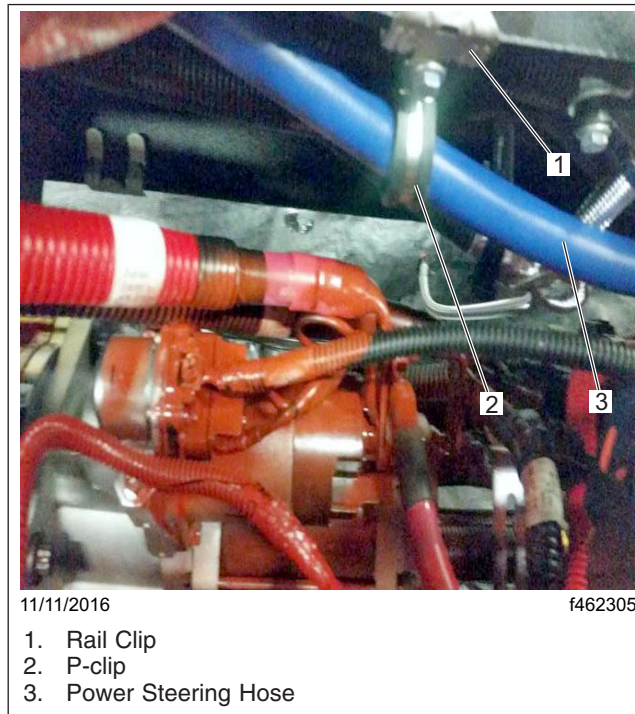
On certain motorhome chassis, the high pressure power steering hose may be routed with inadequate clearance between the hose and a power stud on the starter motor. This may cause the hose to chafe against the power stud on the starter, potentially leading to arcing and, in addition, may cause loss of fluid, short circuit, and melting. Electrical arcing in the presence of leaking power steering fluid can increase the risk of a fire.

Fig. 1, Power Steering Hose with P-Clip (body removed for clarity)

- 6.1 If the power steering hose is held with a P-clip near the starter stud, no work is needed. See [Fig. 1](#). Clean a spot on the base label (Form WAR259). Write the recall number, FL727, on a completion sticker (Form WAR260), and attach it to the base label.

1. Install a rail clip on the top flange of the frame rail, just above the starter.
2. Using a P-clip, bolt, nut, and washer, secure the power steering hose on the rail clip. See [Fig. 1](#). Tighten the nut 72 lbf-in (813 N-cm).
3. For additional security, install tie bands around the hose to the harness near the frame rail within 18 inches (46 cm) of the P-clip.
4. Clean a spot on the base label (Form WAR259). Write the recall number, FL727, on a completion sticker (Form WAR260), and attach it to the base label.
