JTB00640NAS1

TECHNICAL BULLETIN

501-25C: Body Repairs - Water Leaks

Water Trapped In Front And/Or Rear Door(s)

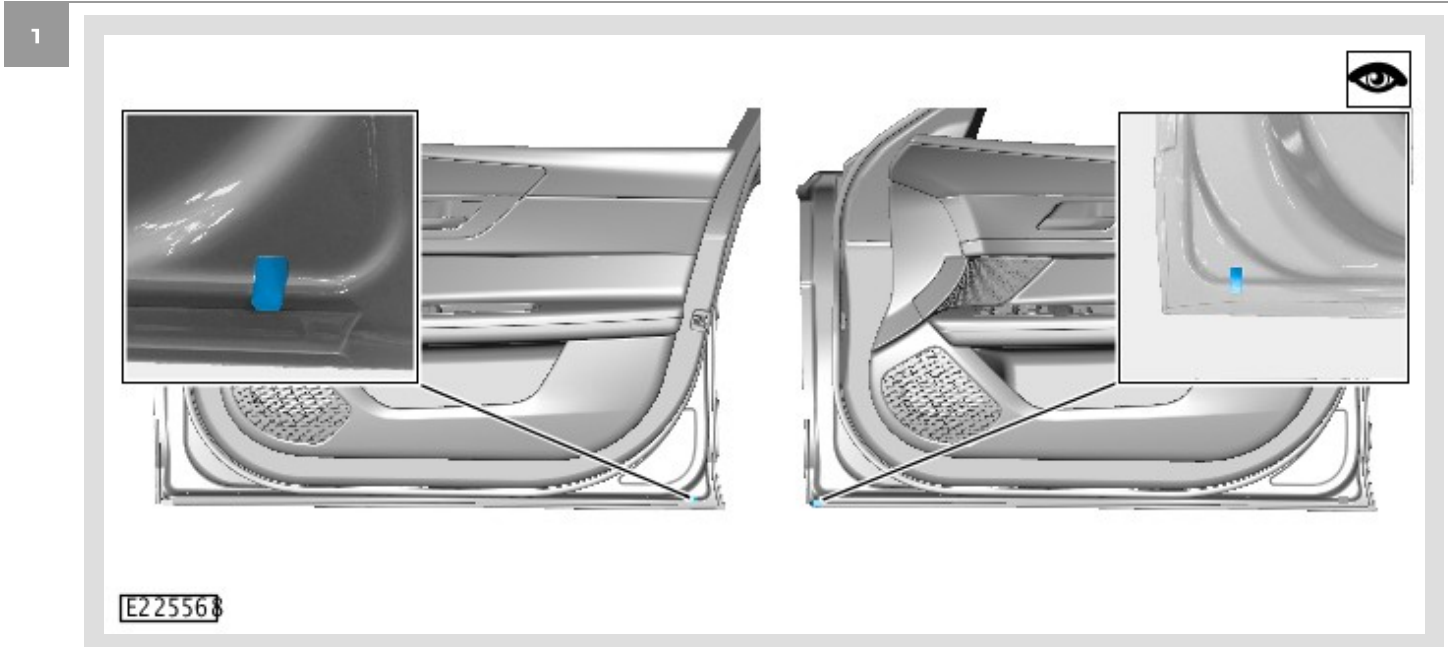
A slosh/slap noise from the front and/or rear door(s) may be evident. Upon further inspection, water may be found to be trapped in the door(s).

This may be caused by door sealant has not being applied to the required specification.

Inspect the front door(s) inner and outer drainage aperture(s) for any excess sealant obstructing the drainage aperture(s).

Use a suitable tool to remove the excess sealant from the drainage aperture(s) and apply paint to the reworked area(s).

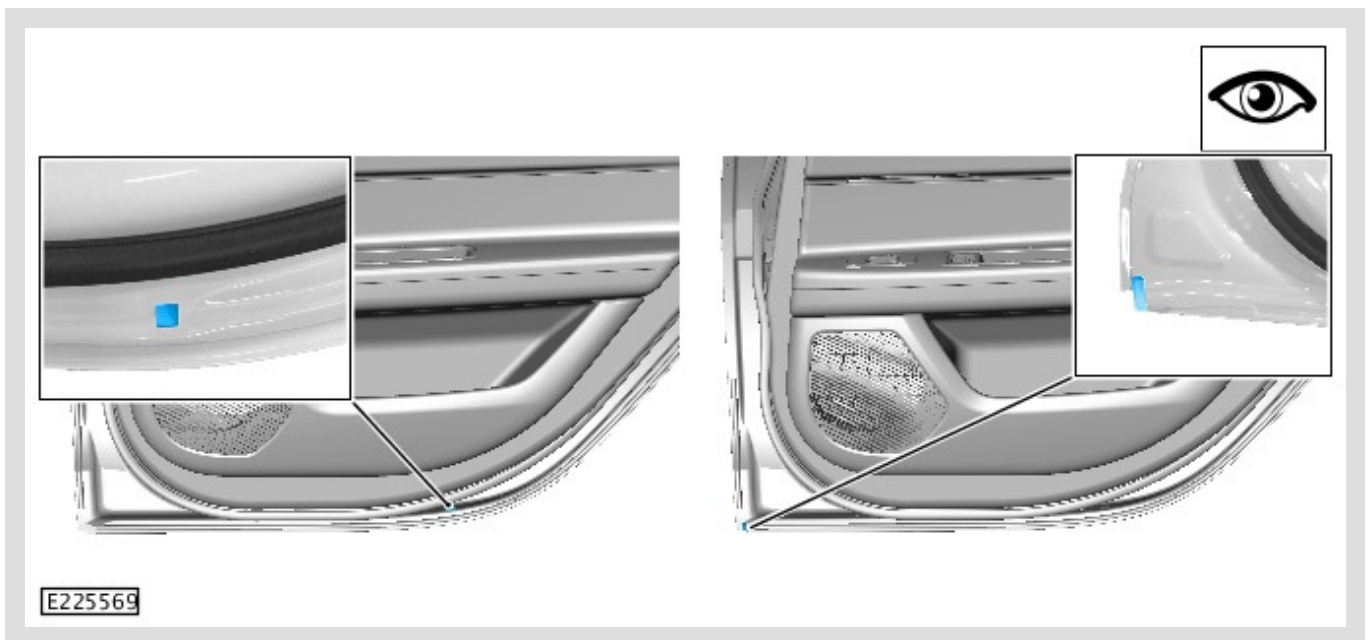
1

Inspect the rear door(s) inner and outer drainage aperture(s) for any excess sealant obstructing the drainage aperture(s).

Use a suitable tool to remove the excess sealant from the drainage aperture(s) and apply paint to the reworked area(s).
