H110NAS2  
**TECHNICAL BULLETIN**  
 11 MAY 2018

501-25C: Body Repairs

Service Action: A-Pillar Water Ingress

MODEL:	MODEL YEAR:	VIN:	ASSEMBLY PLANT:
XE (X760)	2017-2018	P10647-P17694	Castle Bromwich

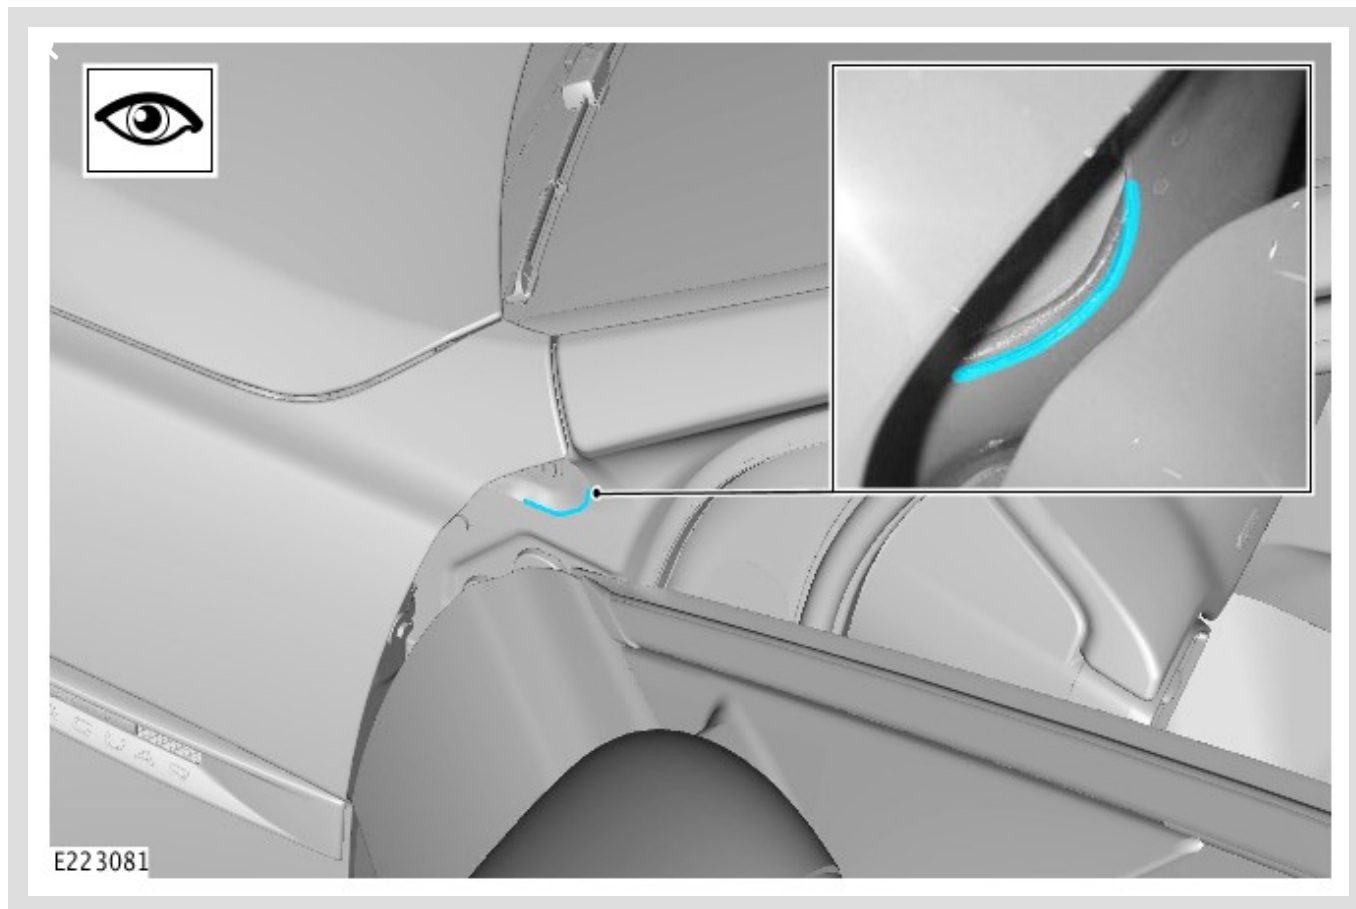
1

An issue has been identified on certain vehicles within the listed Affected Vehicle Range where due to a change to the robotic sealing process, a small area of sealant at the left and right A-pillar was omitted. As a result of this, water can run through this area into the passenger compartment of the vehicle.

Left A-pillar area shown; right A-pillar area similar.

Area in which water can enter the passenger compartment.
