JTB00609NAS2

TECHNICAL BULLETIN

204-02: Rear Suspension

Boom Noise Heard In The Passenger Compartment

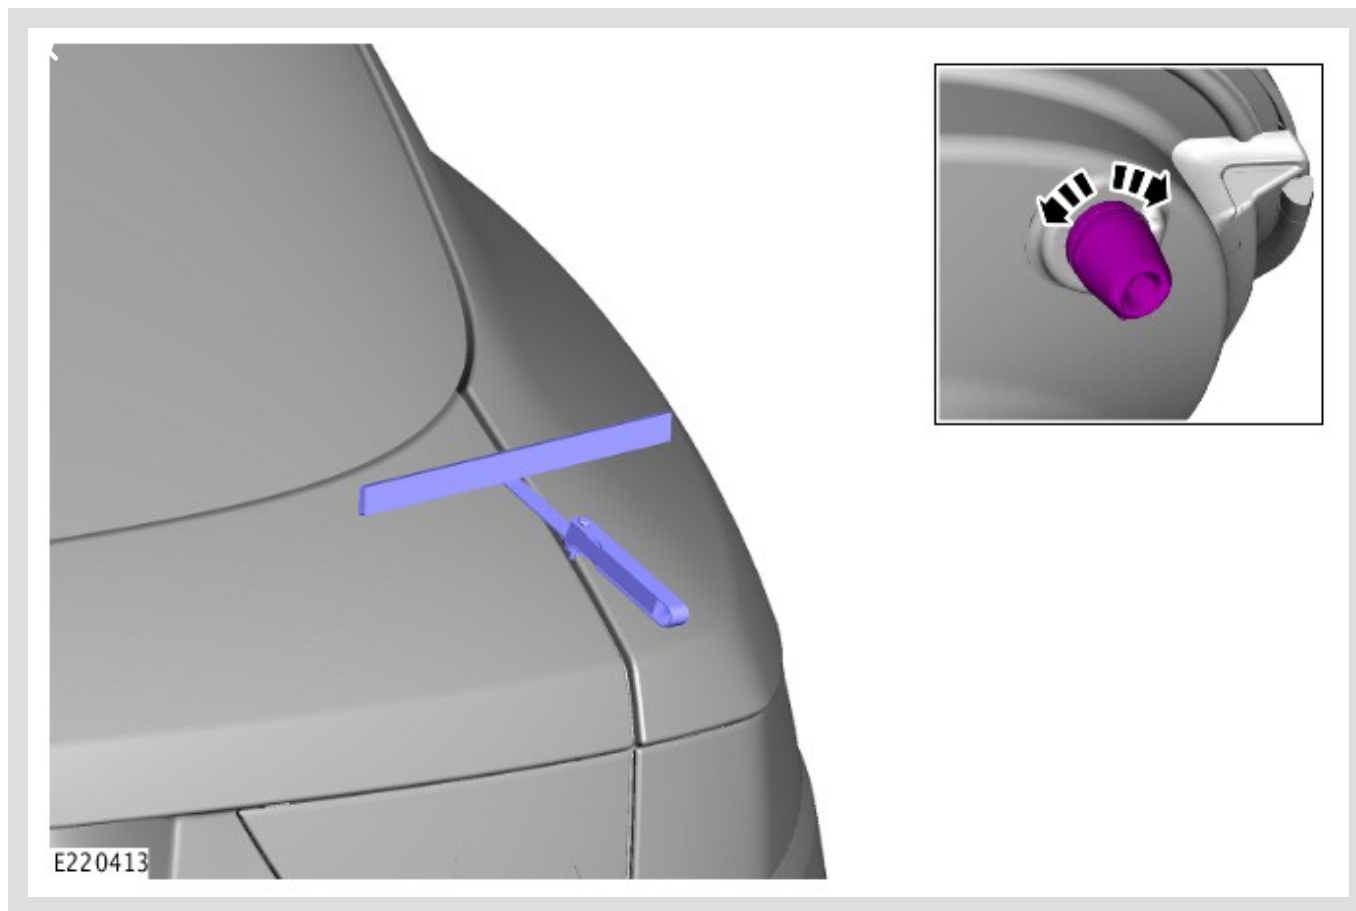
- Incorrect rear subframe alignment; or
- Incorrect alignment of the tailgate.

Use a suitable straight edge and a feeler gauge to set the tailgate alignment to 2.5 mm under flush.
