JTB00457NAS1

TECHNICAL BULLETIN

303-04E: Fuel Charging and Controls - Turbocharger

Whine/Whistle Noise From The Turbocharger

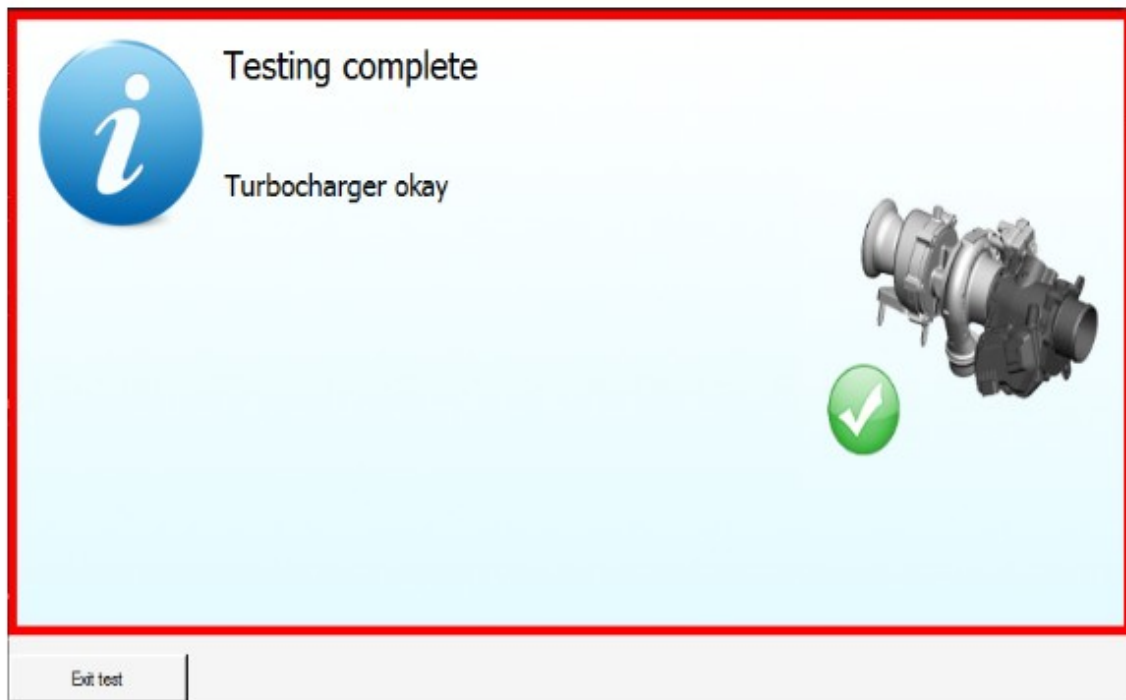
E203627

Example of a 'pass'.

- If the turbocharger does pass (✓) the diagnostic test, carry out further diagnostics (see TOPIx Workshop Manual section 303-04E: Fuel Charging and Controls -

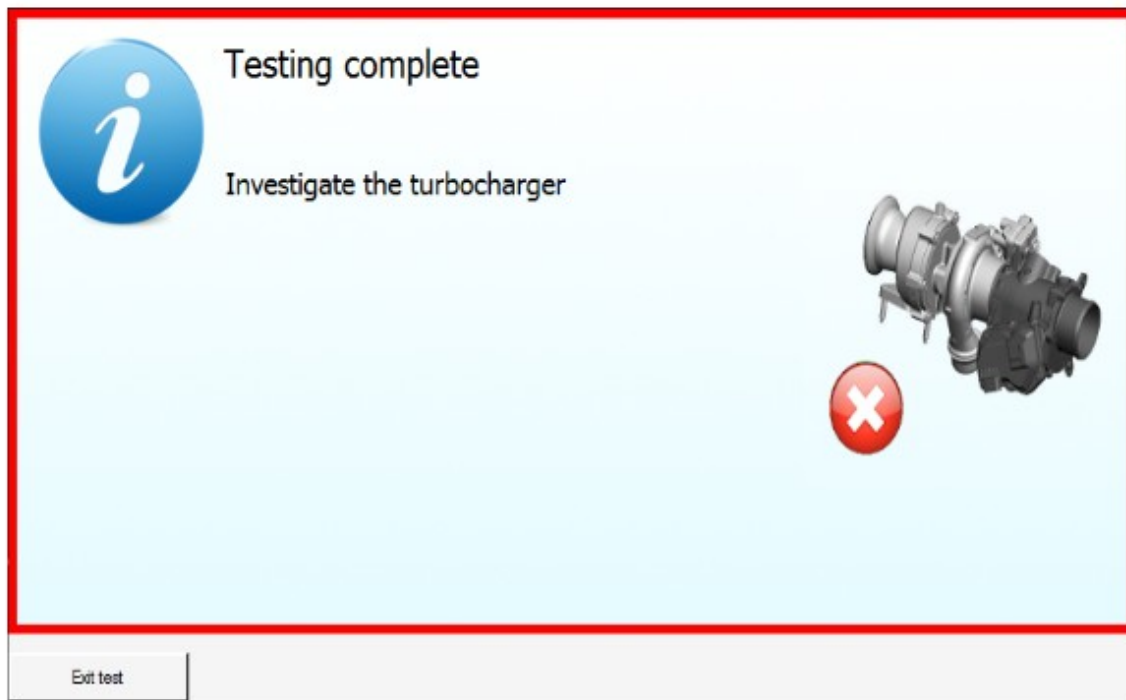
E203628

Example of a 'fail'.

- If the turbocharger does not pass [fails - (X)] the diagnostic test, replace the turbocharger (see TOPIx Workshop Manual section 303-04E: Fuel Charging and Controls - Turbocharger - INGENIUM I4 2.0L Diesel - Removal and Installation - Turbocharger).
