# MIL "ON" P125D71 – Fuel Flow Control Valve Stuck

Some 2015 – 2016 model year NX 200t vehicles may exhibit a MIL “ON” condition with Diagnostic Trouble Code (DTC) P125D71 (Fuel Flow Control Valve Performance Actuator Stuck). Some vehicles may also enter “limp mode” and the Multi-Informational Display (MID) will tell the customer “reduced engine power – take vehicle to nearest dealer”. Follow the procedures in this bulletin to address this condition.

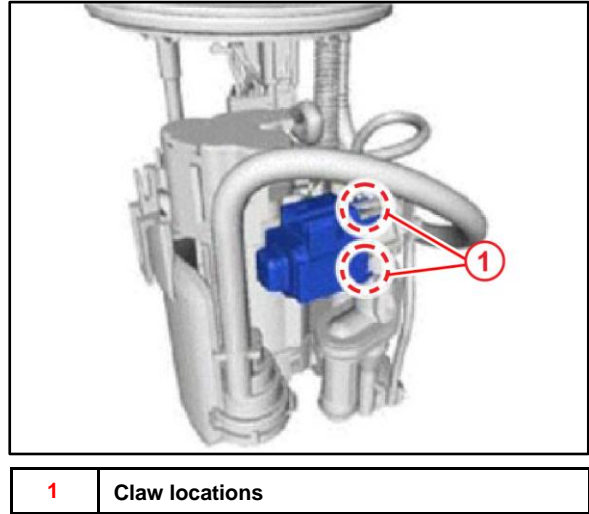
**Figure 1.**

7. Remove the pressure discharge valve from the fuel suction plate sub-assembly.
  - A. Disconnect the connector from the pressure discharge valve assembly.
  - B. Detach the 2 claws and pressure discharge valve assembly from the fuel suction tube assembly with pump.

8. Install the new pressure discharge valve and attach the 2 claws and pressure discharge valve assembly to the fuel suction tube assembly with pump.
9. Reassemble the fuel pump with the new Sub-Tank, plate and applicable O-Rings.  
Refer to TIS, applicable model and model year Repair Manual:
