Abnormal "Squeak" Noise From Rear Suspension Over Uneven Roads

Service Category Suspension

| YEAR(S) | MODEL(S) | ADDITIONAL INFORMATION |
|---|---|---|
| 2014 - 2017 | Highlander, Highlander HV | |

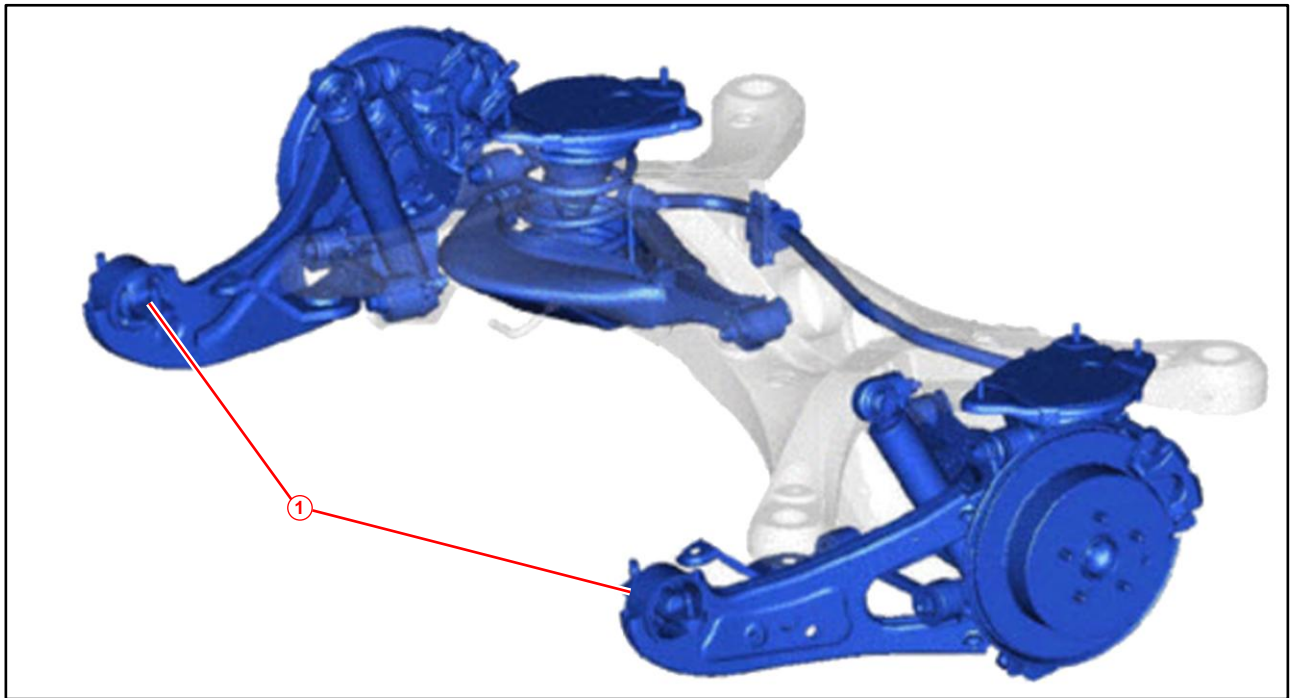
Figure 1.

Some 2014 – 2017 model year Highlander and Highlander HV vehicles may exhibit an abnormal squeak, squawk or groan type noise from the rear suspension when traveling over uneven roads, or when the vehicle comes to a complete stop, which may become more pronounced in colder ambient temperatures. The abnormal noise may be caused by the rear trailing arm bushing. An updated Rear Trailing Arm Assembly is available. Follow the Repair Procedure in this bulletin to address this condition.

| 1 | Rear Trailing Arm Assembly Bushing |

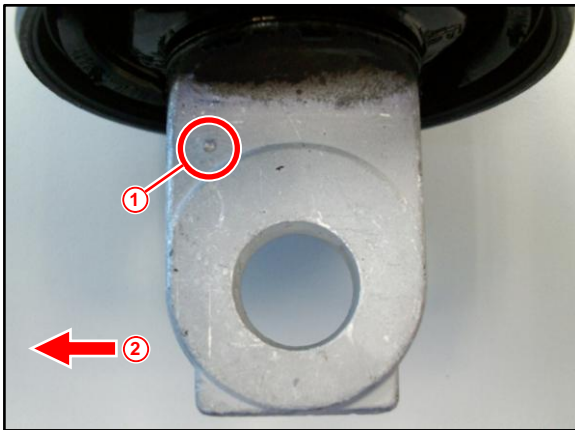
Figure 2. LH Side

- BEFORE installing NEW parts, confirm the identification mark as shown. If this mark is NOT present, the part is incorrect and SHOULD NOT BE INSTALLED.

The identification mark on the NEW parts faces the outside of the vehicle.
