Technical Service Bulletin

Subject: CHECK ENGINE LIGHT ON WITH DTC P2610 AND P2507	Bulletin No.: 01-012/18
	Last Issued: 05/08/2018

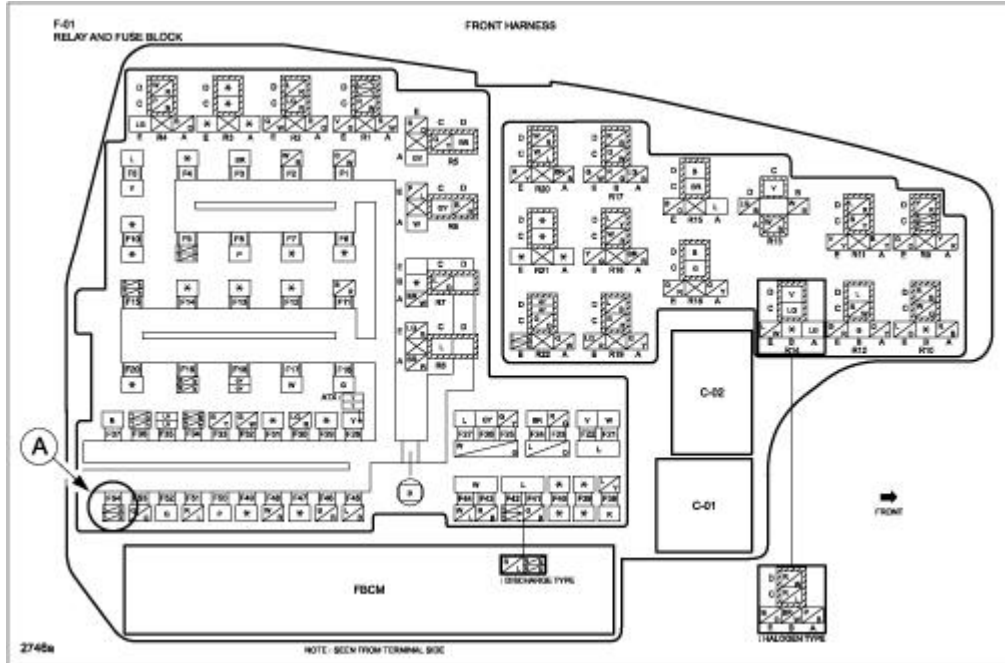
As a past malfunction, the customer will not notice it (no warning light illuminated), but the DTC may be found during a vehicle service. P2507 in this situation is only applicable on 2016 and later models.

This is caused by the engine being started 3 or more times after a short duration of engine off (less than 15 seconds) with the room fuse removed.

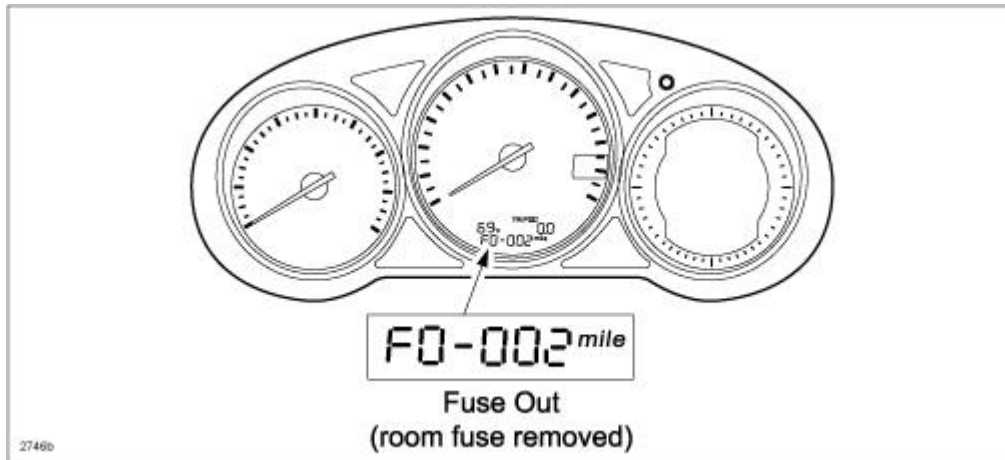
NOTE: The odometer will display "F0-002" during transport mode (room fuse 15A removed). Transport mode is canceled when room fuse 15A is installed or the vehicle odometer is more than 12.4mi (20km).

Vehicles in dealer inventory with this concern should be repaired using the following repair procedure.

1. Verify DTC P2610 and P2507 are stored in PCM memory.
2. Install ROOM fuse 15A with ignition OFF.
3. Start the engine and let it run for at least 10 seconds, then stop the engine.
4. Start the engine again and verify that the CHECK ENGINE LIGHT is not illuminated, then stop the engine.
5. Clear DTC P2610 and P2507 from PCM memory using IDS.
6. Verify no other DTCs are stored in memory. If so, troubleshoot them according to the MGSS online instructions or Workshop Manual.
