<b>Reference</b>	SSM73709
<b>Models</b>	Discovery / L462 Range Rover / L405 Range Rover Sport / L494
<b>Title</b>	8HP45 Automatic Transmission Casing Oil Leak 2017/2018MY Vehicles
<b>Category</b>	Driveline
<b>Last modified</b>	11-Apr-2018 00:00:00
<b>Symptom</b>	501000 Automatic Transmission Concerns
<b>Attachments</b>	18HP45 Transmission Casing Leak.pdf

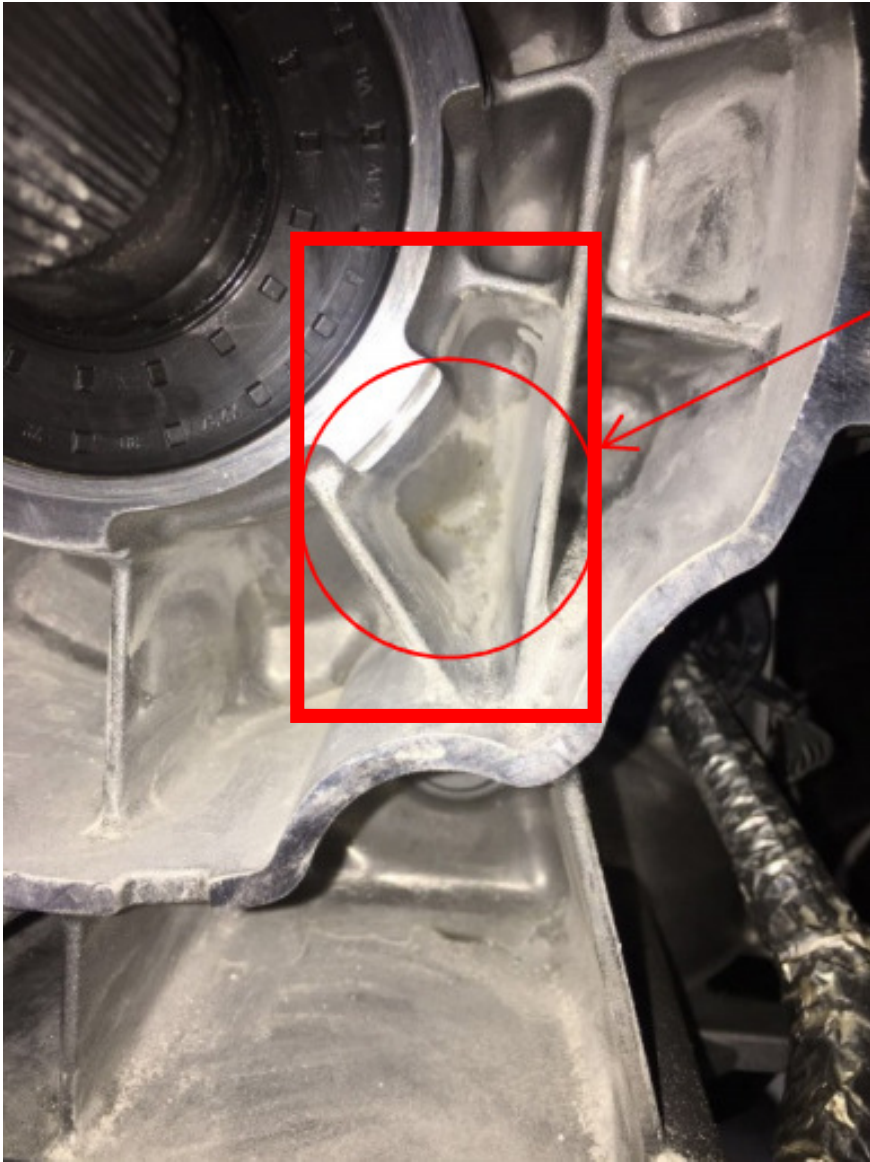
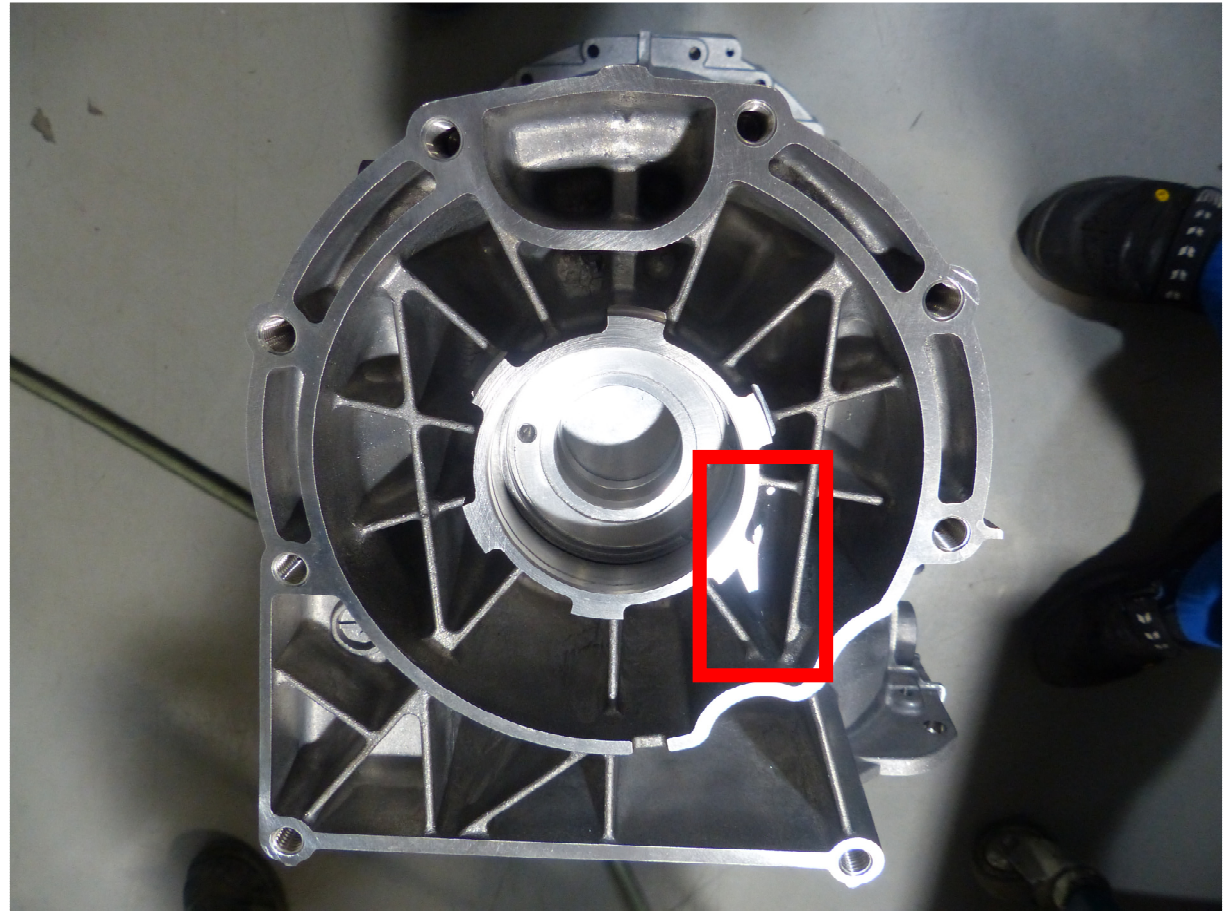
Oil weeps through the aluminium casing in the rear extension housing of the transmission in the base of the pocket around where the steel D clutch steel tube is embedded.

Internal porosity in the area of the extension casing allows oil to reach the end of the small pocket under the tube where it is prone to casting skin damage during casting. Oil then drips from the drain hole in the space between the transmission and transfer box.

- Remove the transfer case assembly.
- Inspect the area as shown in the attached file.
- Confirm leak is as shown in the attached file.

Submit a FRED for an automatic transmission replacement attaching clear photos confirming the issue
