**July 3, 2018**

05806 Version 5

## Product Update: Roof Molding

Supersedes 16-021, dated February 16, 2017 to revise the information highlighted in **yellow**

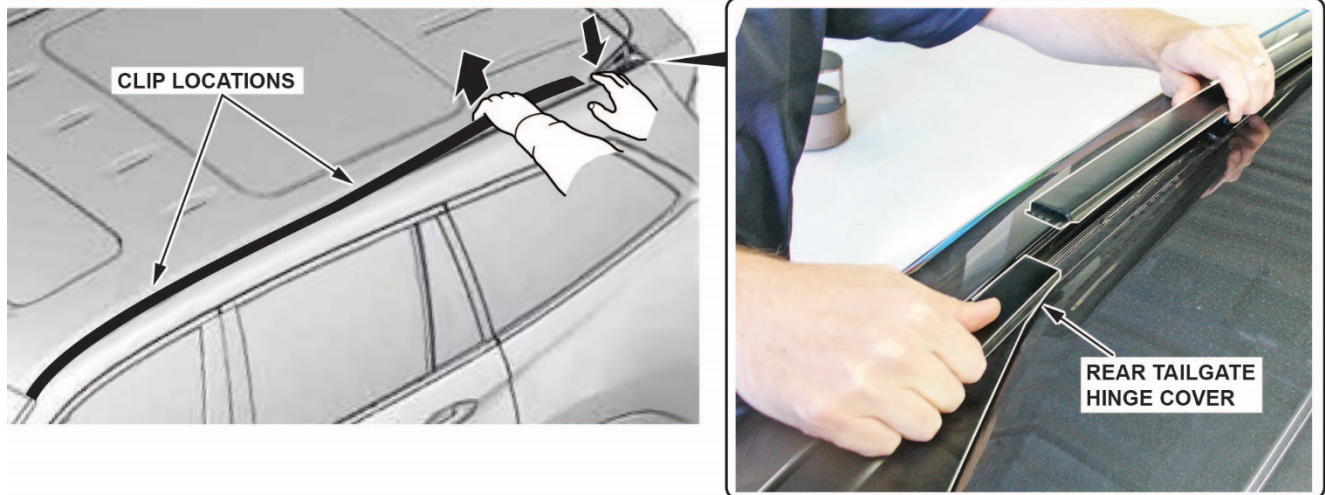
- Starting at the back of the vehicle, place your hand over the rear tailgate hinge cover and gently lift in the area shown until the roof molding tongue is free from the rear tailgate hinge cover.

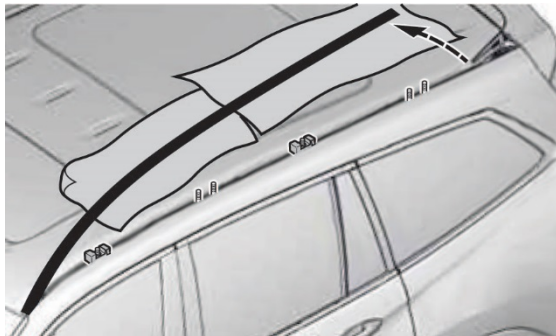
- Be careful to not damage the molding or the vehicle's paint. Use a shop towel or similar item to protect the roof from being scratched.
- Do not move the molding past the first rib in the roof because you may loosen the front cap.
- If the front cap does come loose, secure it with about 1 gram of Honda bond. Apply it to the clip area where the adhesive pad was located and reattach the molding.

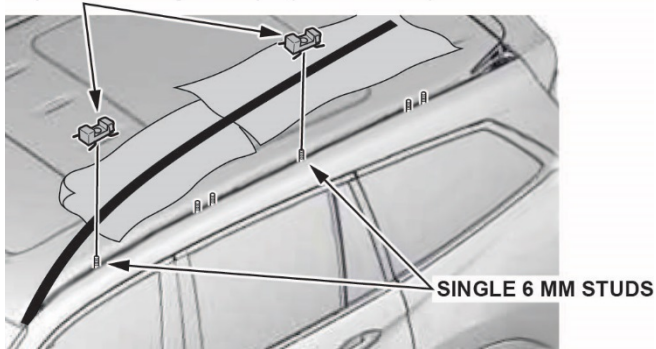
Replace existing M6 clips (natural color).

3. Install the two M6 clips (natural color) in the same location as the original clips (the single 6 mm studs).
4. Install the front M8 roof clip (yellow color) on the first stud of the double 8 mm stud as shown, then install the second M8 roof clip on the second double 8 mm stud.

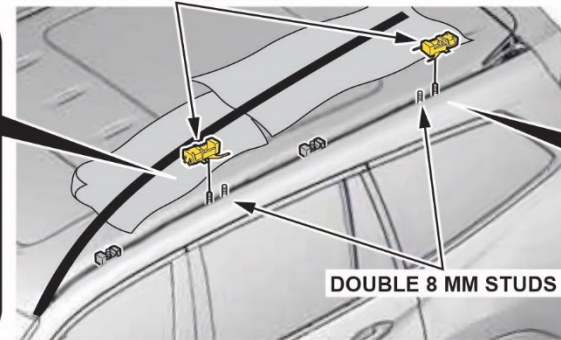
Add two M8 clips (yellow).
